Fairfield Public Schools
Fairfield, CT 06825

RE: Woodard and Curran Follow-up Assessment Report

Re: **Follow-up Building Surveys**
Fairfield Public Schools

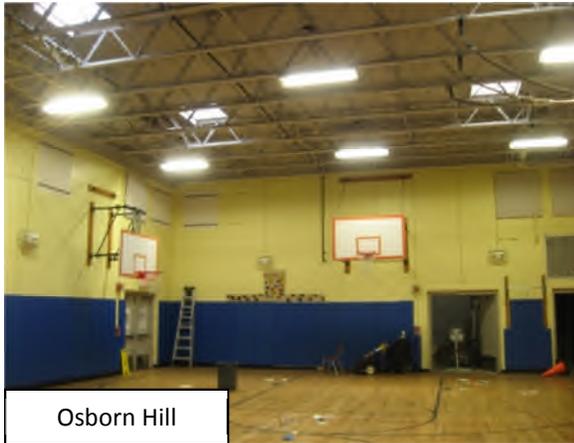
The spray-on material was observed on metal framed ceiling joists in the gym overhead areas of both buildings. The ceiling joists are approximately 20 to 25 feet above the gym floors. Unlike Osborn Hill, at the Timothy Dwight School, a wooden lathe ceiling is present along the bottom of the joists (access to the joists was via an access opening); therefore the spray-on coating is not as accessible or visible as at Osborn Hill. See photos below.

The spray-on fireproofing materials observed at both the Osborn Hill and Timothy Dwight Schools were white, brittle, and moderately hard (breaks apart with hand scraper). At Timothy Dwight, the materials appeared to be in good condition with no pieces observed on the top of the wood ceiling.

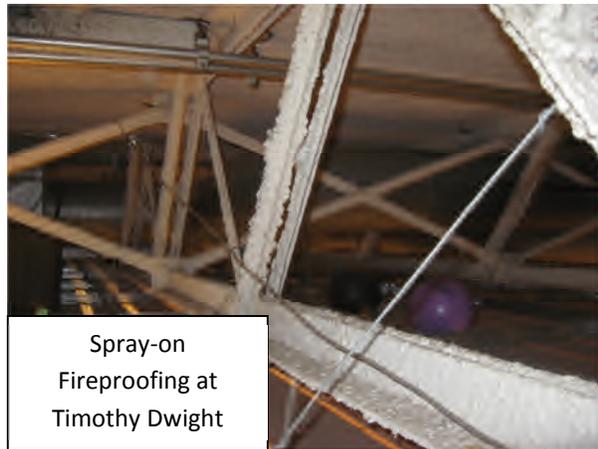
Spray-on Fireproofing at Timothy Dwight

During the follow-up survey, samples of the spray-on materials were collected from both schools for chlorine screening using the XRF. Because the overhead area was not accessible at the Osborn Hill Elementary School, the samples were collected from the floor where materials were found. At the Timothy Dwight School, the ceiling was accessed by an aerial lift. Results are summarized on the table below:
