RE: Woodard and Curran Assessment Report

Re: Assessment of PCBs in Building Materials – School Buildings
Fairfield Public School District

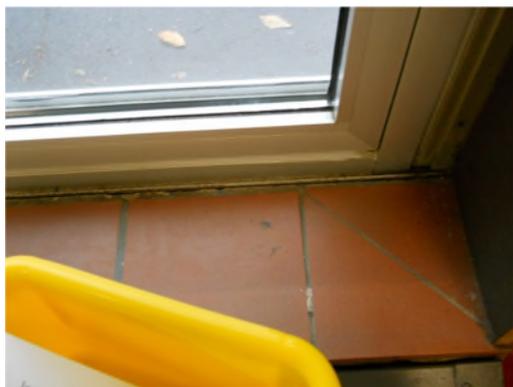
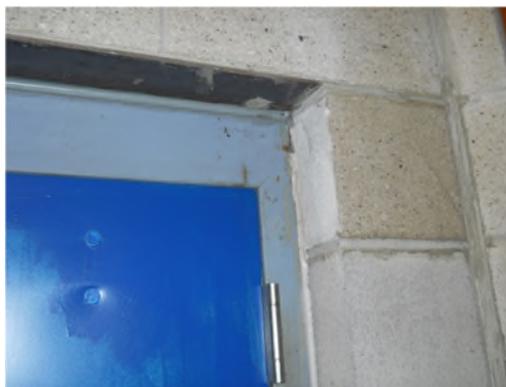
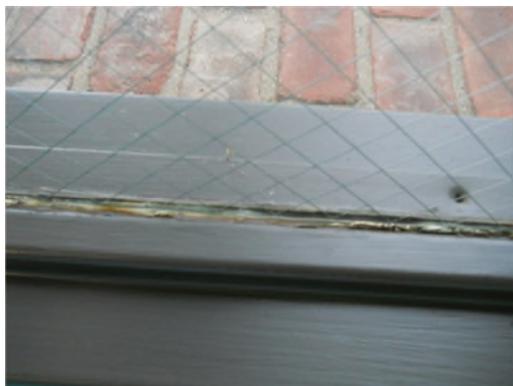
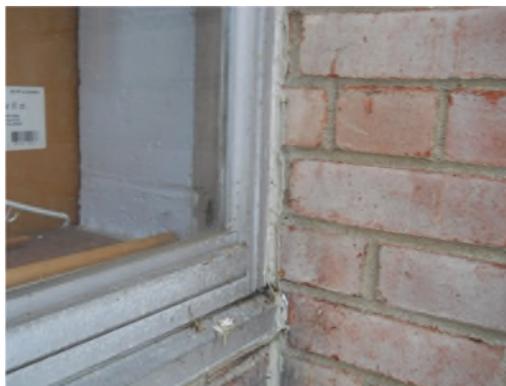
Photos of typical building sealants observed during the building survey are provided below.

- Caulking and glazing sealants were observed throughout the building, primarily associated with window and door systems and expansion joints; the majority of the sealants were observed to be intact and pliable; given the date of construction of the building, these materials are considered suspect for PCBs.

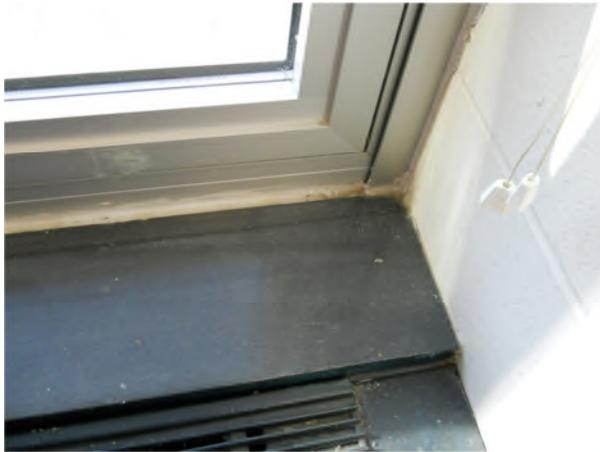
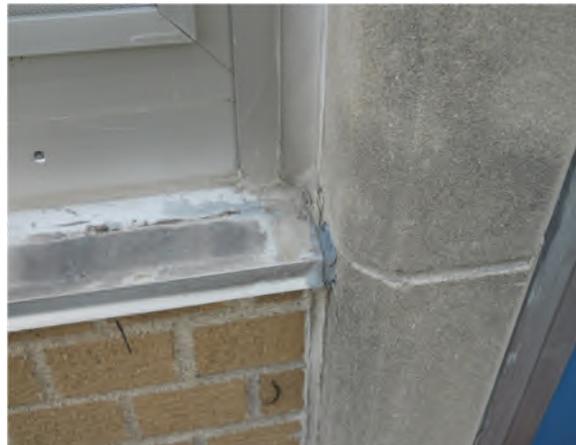
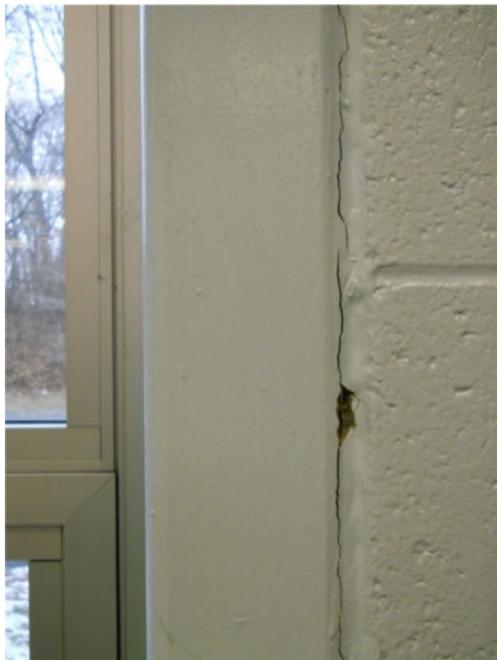
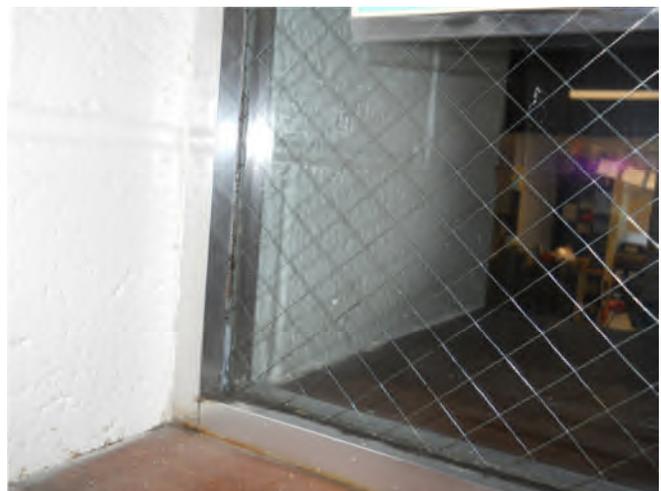
Photos of typical building sealants observed during the building survey are provided below.

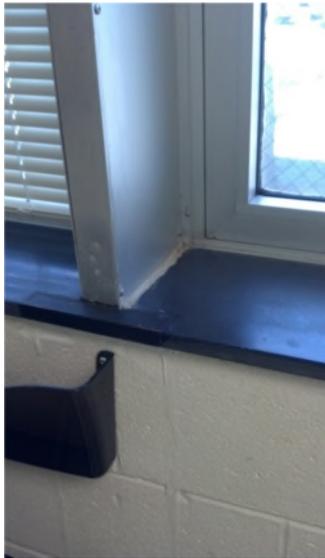
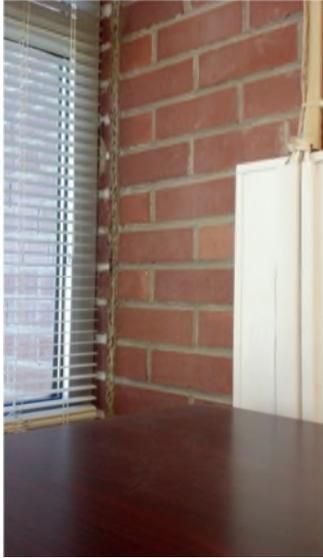
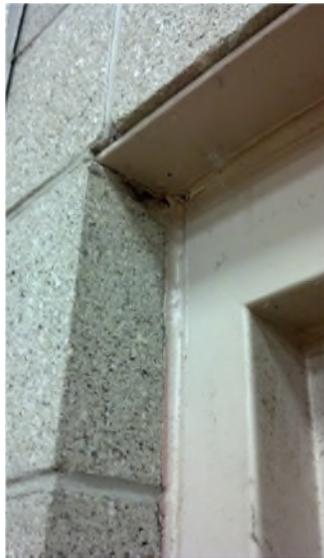
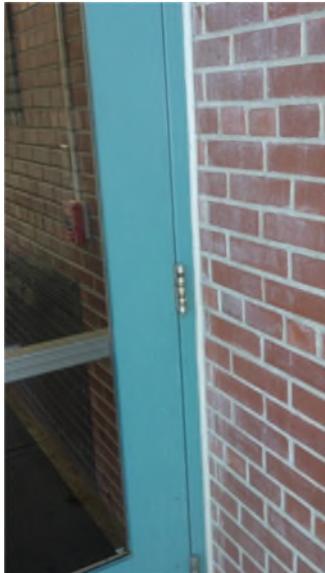
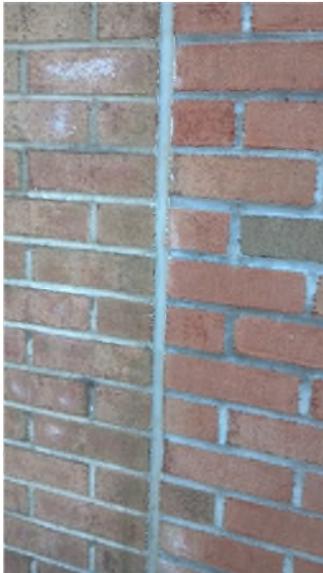
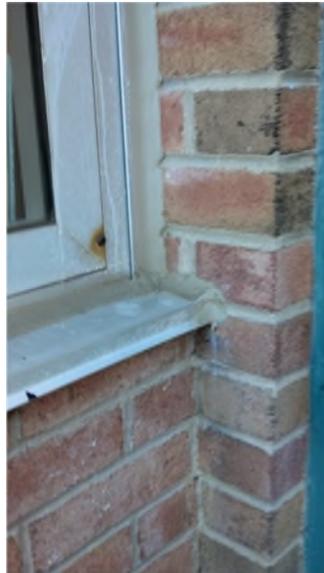
Photos of typical building sealants observed during the building survey are provided below.

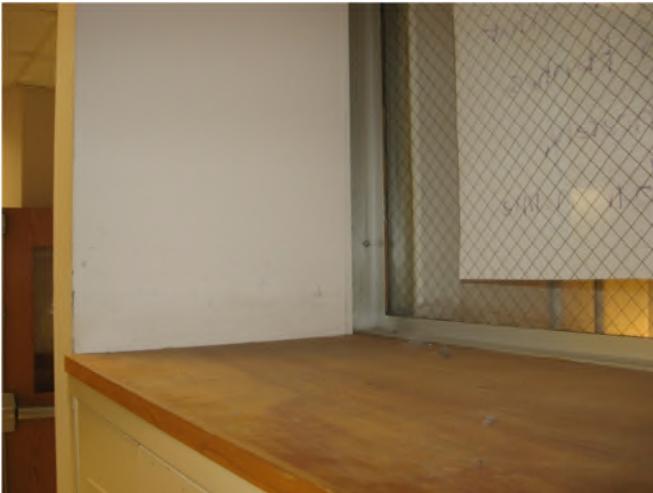
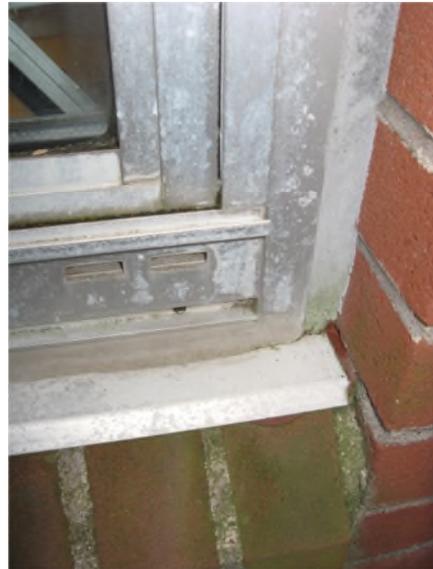
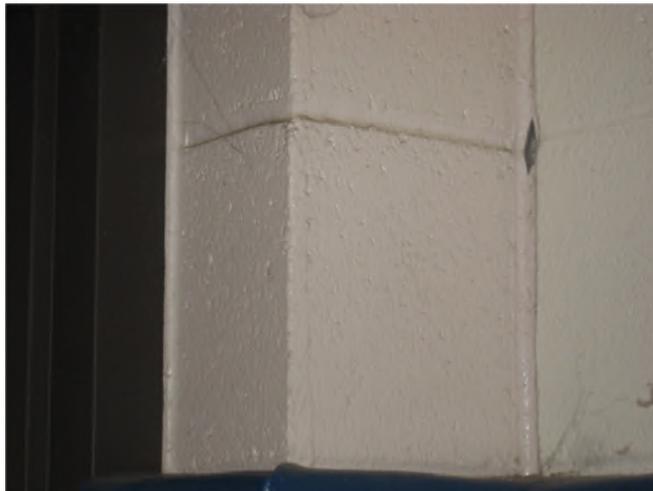
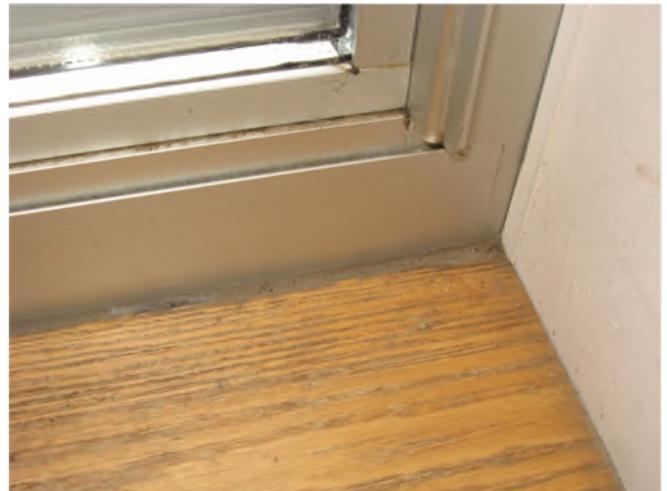
Photos of typical building sealants observed during the building survey are provided below.

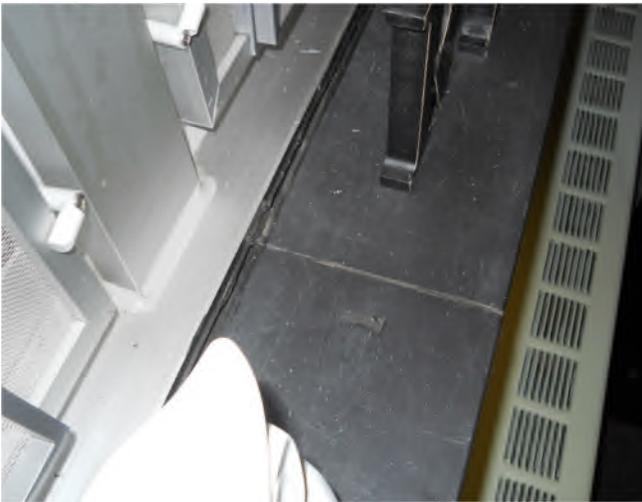
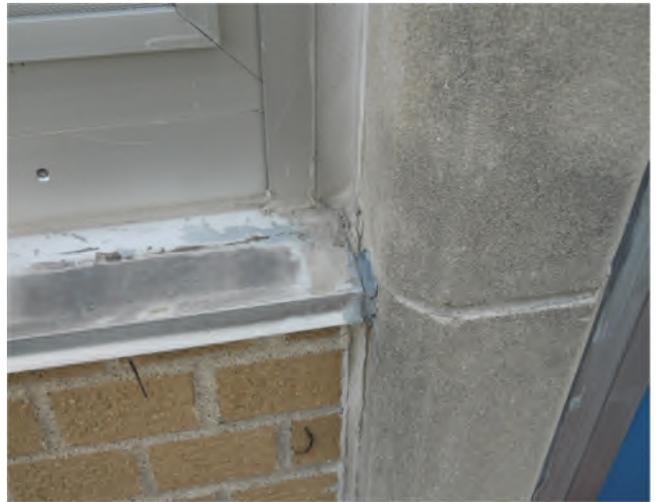
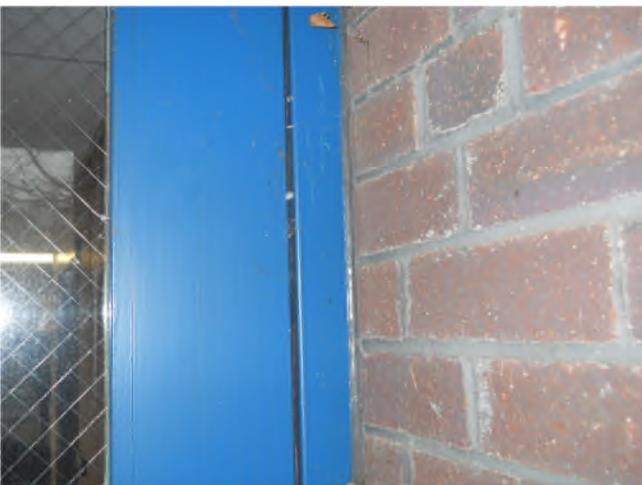
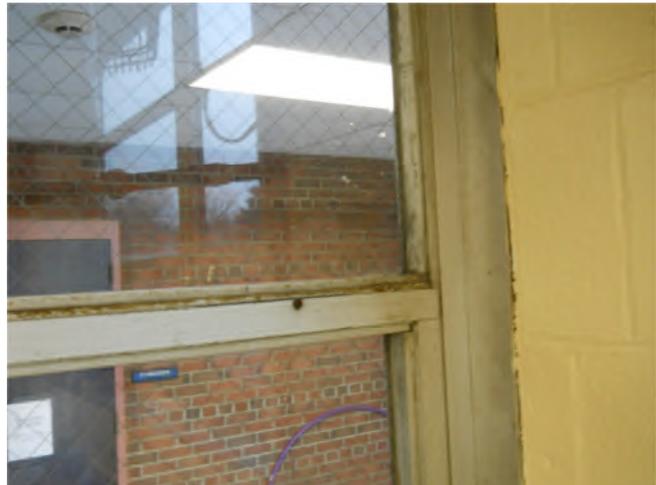
Photos of typical building sealants observed during the building survey are provided below.

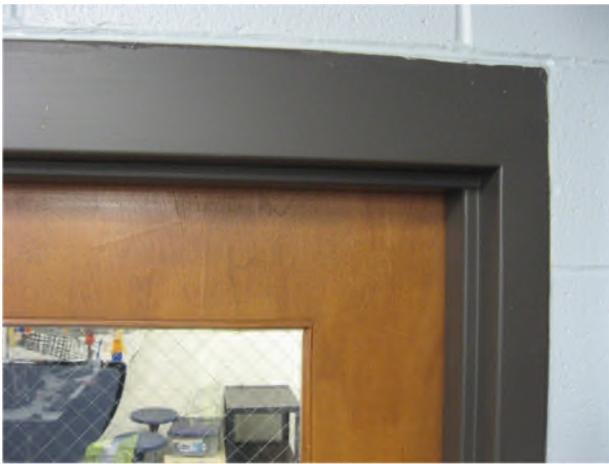
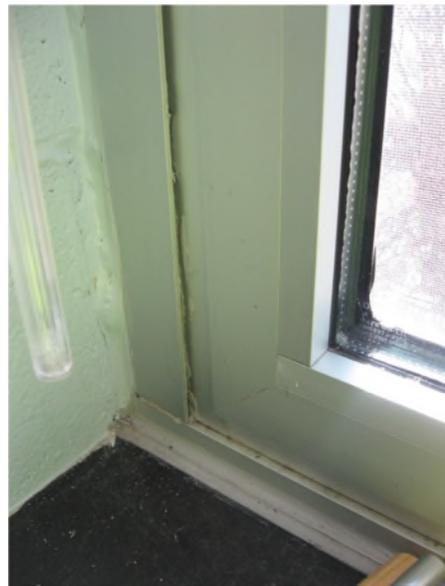
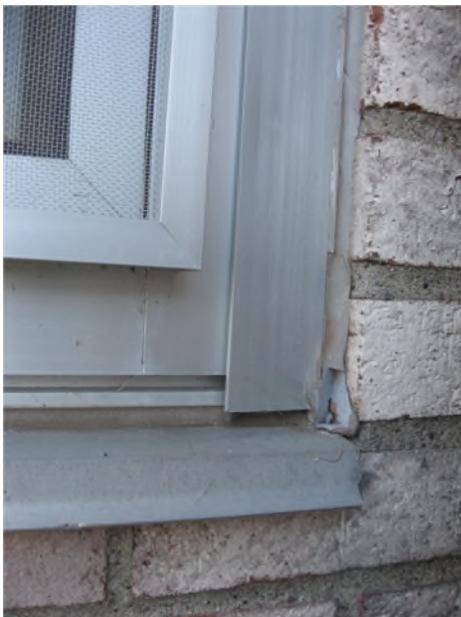
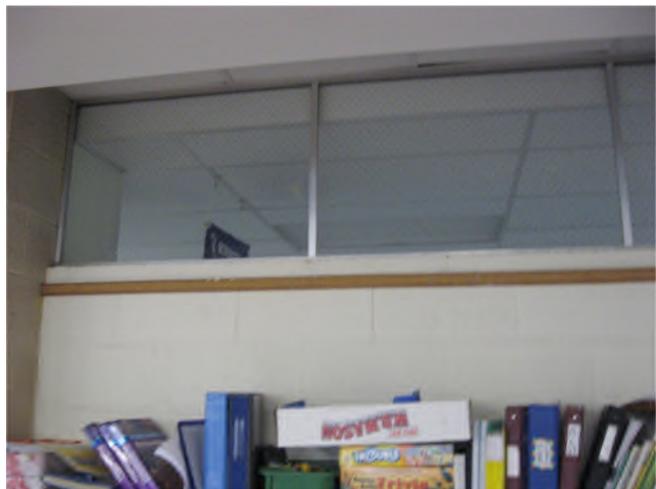
Photos of typical building sealants observed during the building survey are provided below.

Existing Data – Previous samples of suspect materials detected PCBs. Three exterior sealant samples were collected including window frame caulking (PCBs - non detect and 1.6 ppm) and exterior expansion joint caulking (non-detect). Three interior sealant samples were collected including window caulking (non-detect), door caulking (4.3 ppm) and window glazing sealant (1.1 ppm). These concentrations are well below the 50 ppm Federal regulatory threshold for PCB Bulk Product Waste.

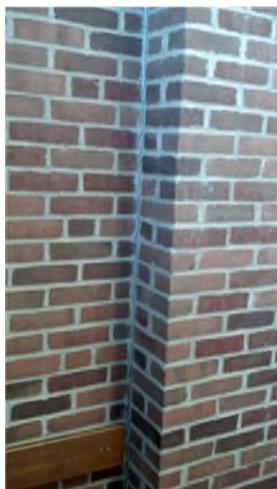
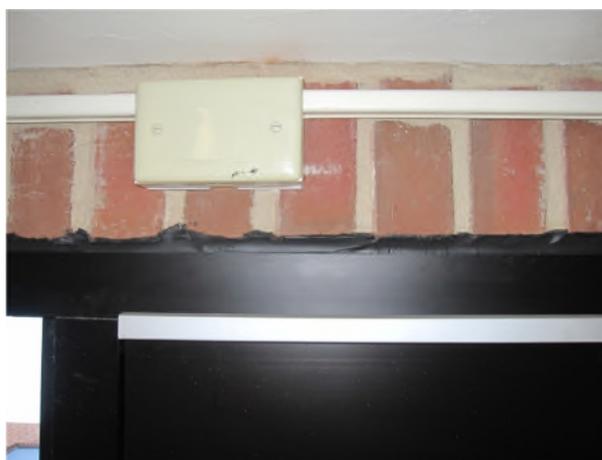
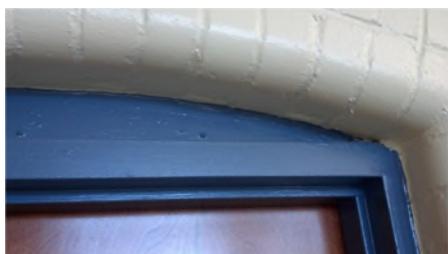
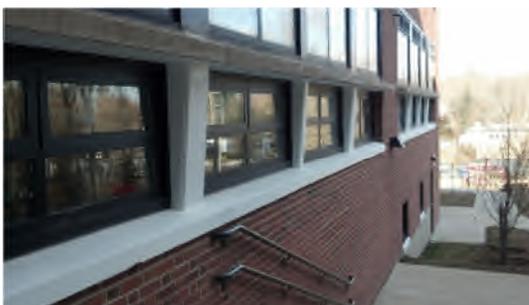
Photos of typical building sealants observed during the building survey are provided below.

- Exterior door caulking samples (<0.82, 1.2, 10, 130, and 58,000 ppm PCBs); concrete expansion joints (<0.83, 0.93, and 19 ppm PCBs); miscellaneous sealants (<0.81, 1, and 5.2 ppm PCBs).

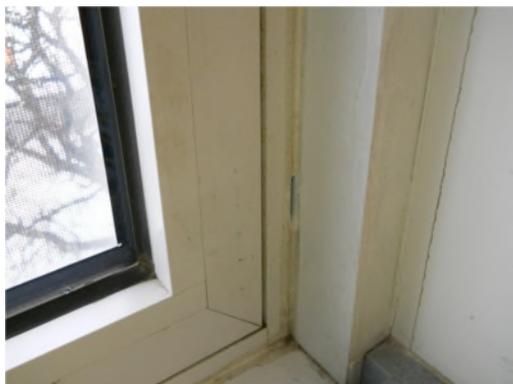
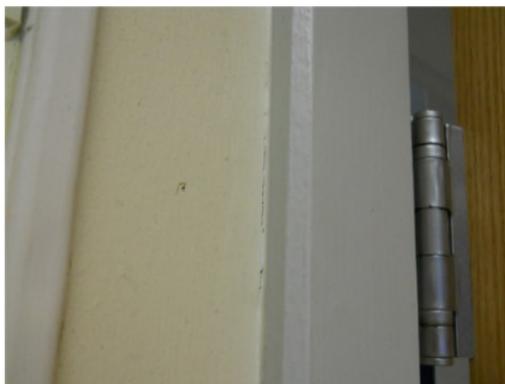
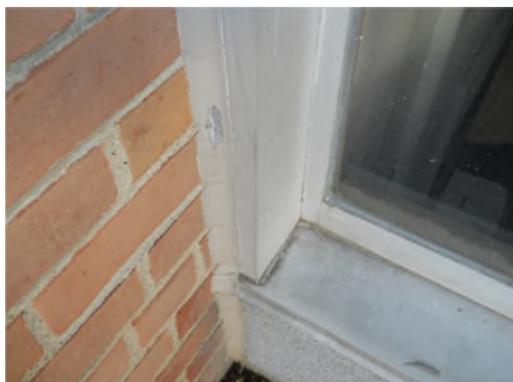
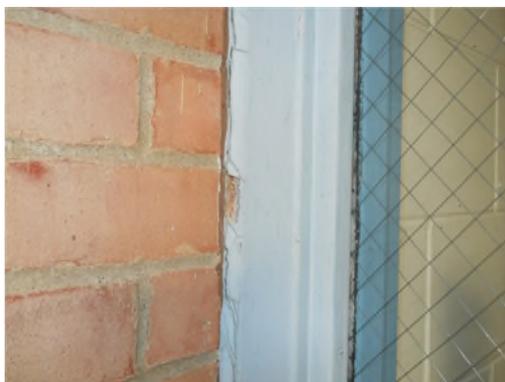
Photos of typical building sealants observed during the building survey are provided below.

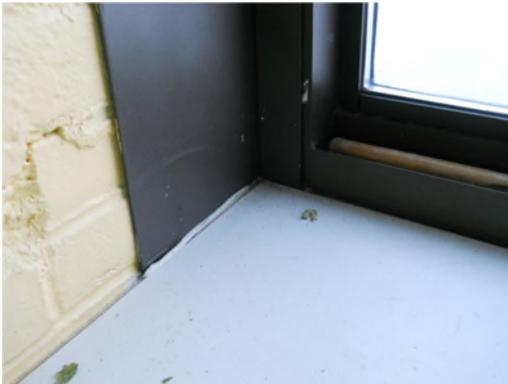
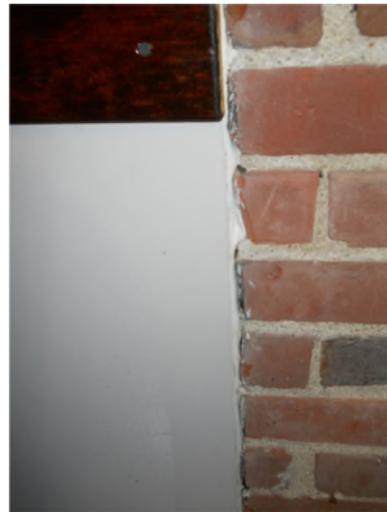
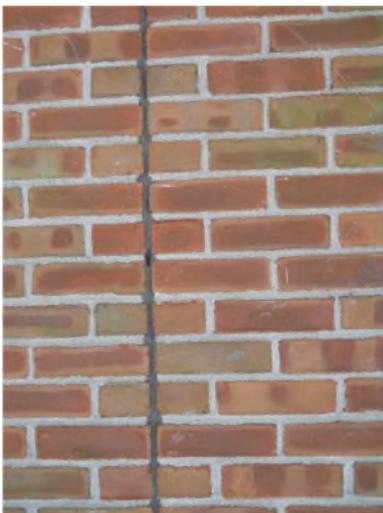
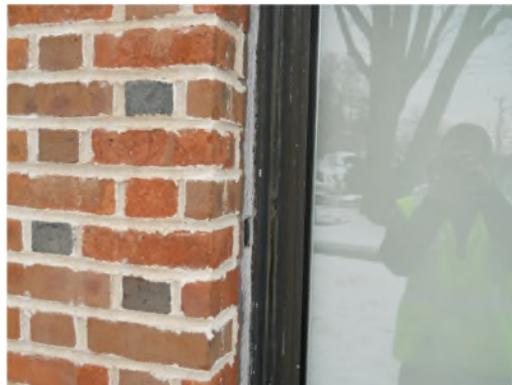
Photos of typical building sealants observed during the building survey are provided below.

Existing Data - Existing samples of suspect materials were collected from the building exterior in association with a 2012 exterior door replacement project, and have been analyzed by a laboratory to determine PCB presence and concentration. PCBs were detected in at least on sample; however, no samples were identified at ≥ 50 ppm. Eleven samples of exterior and interior door caulking (8 reported < 1 ppm, 1 sample at 1.4 ppm, and 2 samples at < 37 ppm PCBs).

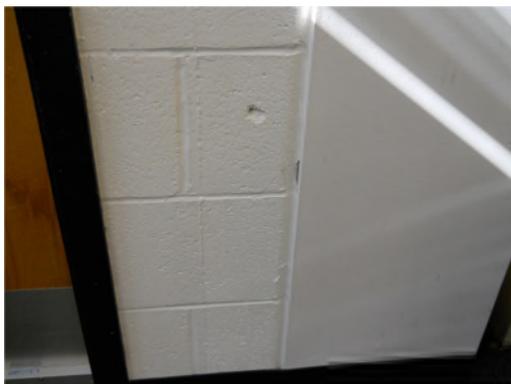
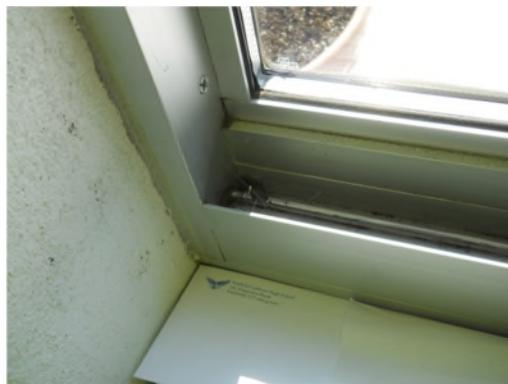
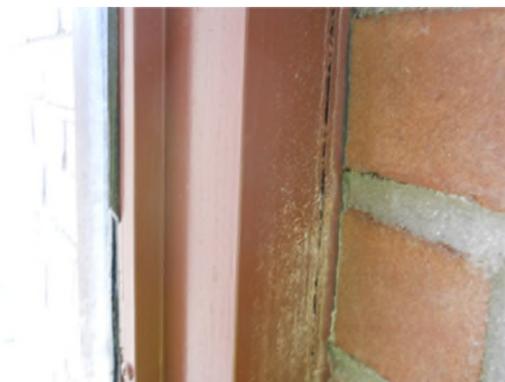
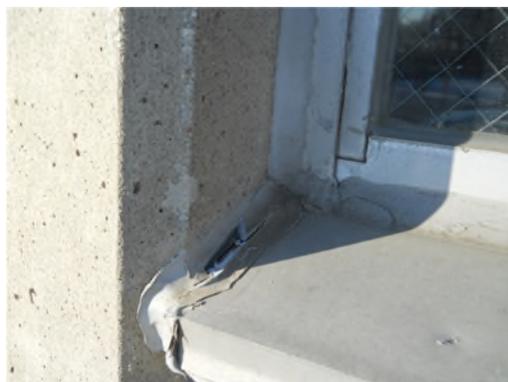
Photos of typical building sealants observed during the building survey are provided below.

- Window caulking and glazing samples collected from October 2011 to July 2012 (multiple events)
 - Exterior and interior caulking samples detected PCBs at concentrations up to 660,000 ppm and 4,900 ppm, respectively
 - Exterior and interior glazing sealant samples detected PCBs at concentrations up to 41,000 ppm and 72 ppm, respectively
- Adjacent building substrate and soil samples collected from July 2012 to January 2013 (multiple events)

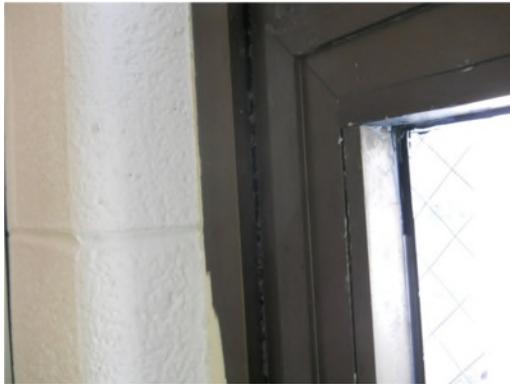
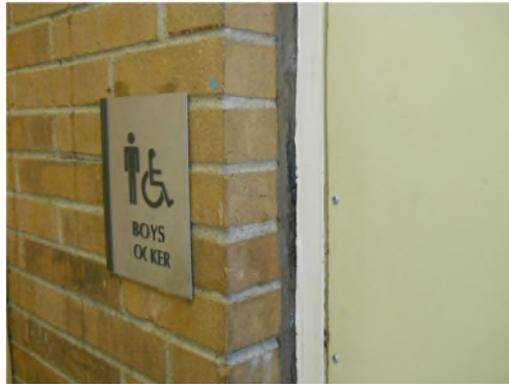
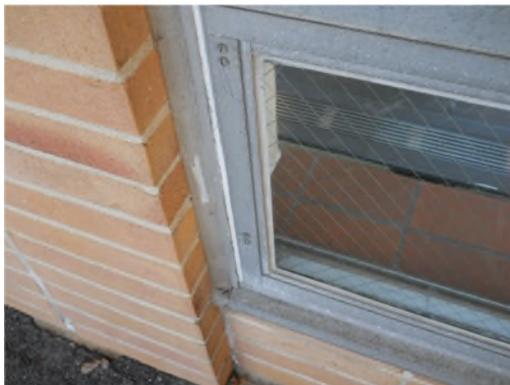
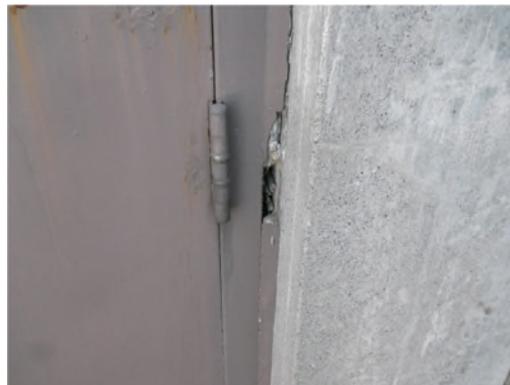
Photos of typical building sealants observed during the building survey are provided below.
