Fairfield Public Schools
Fairfield, CT 06825

RE: Woodard and Curran Follow-up Assessment Report

Re: **Follow-up Building Surveys**
Fairfield Public Schools

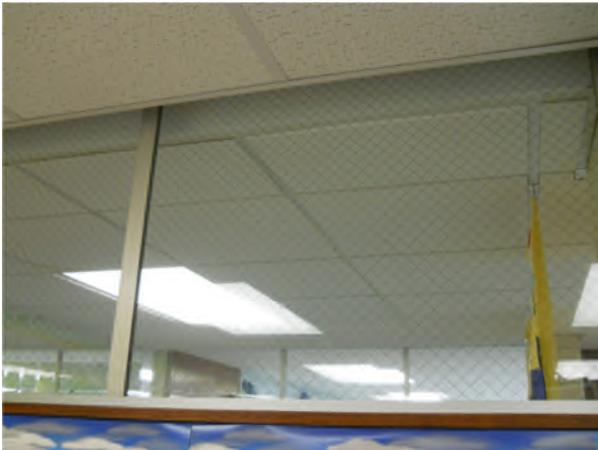
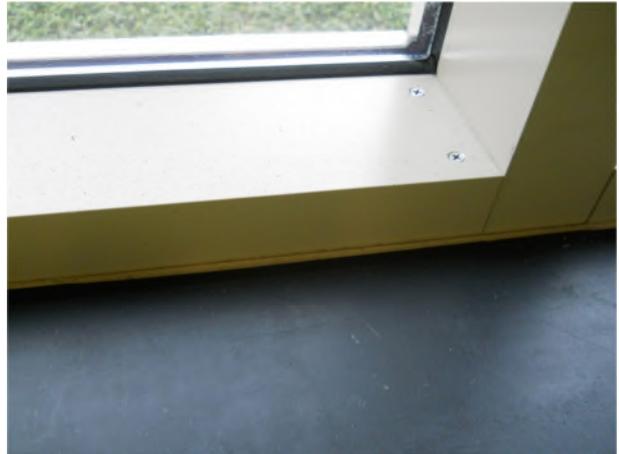
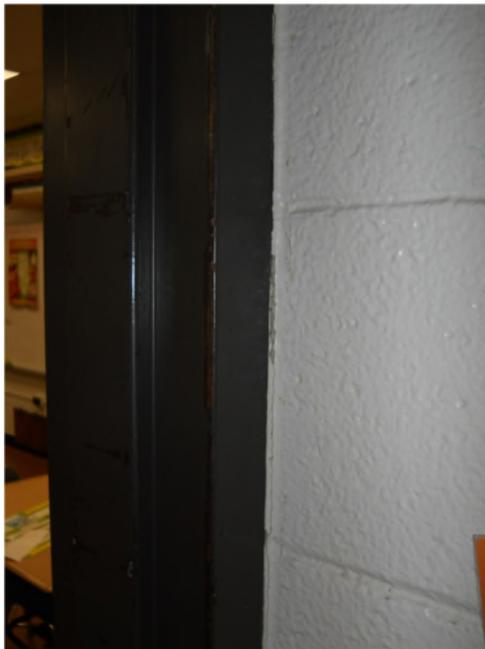
Photos of typical building sealants observed during the building survey are provided below.

- Caulking and glazing sealants were observed throughout the building, primarily associated with window and door systems and expansion joints; the majority of the sealants were observed to be intact and pliable; given the date of construction of the building, these materials are considered suspect for PCBs.

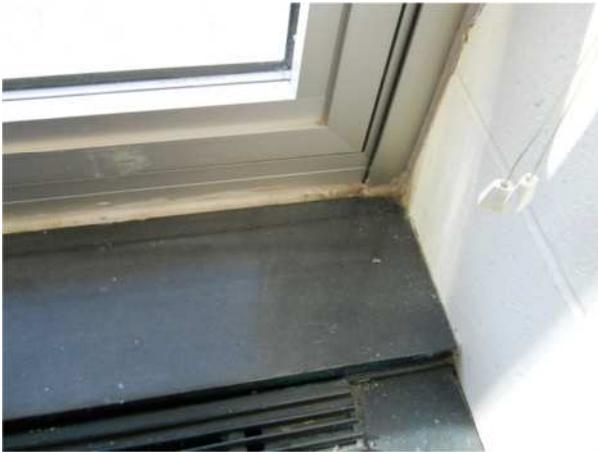
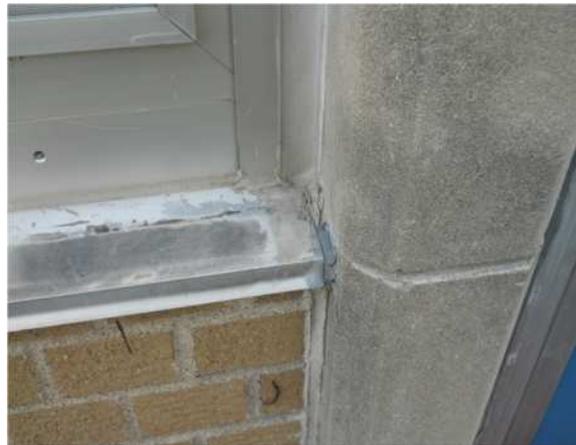
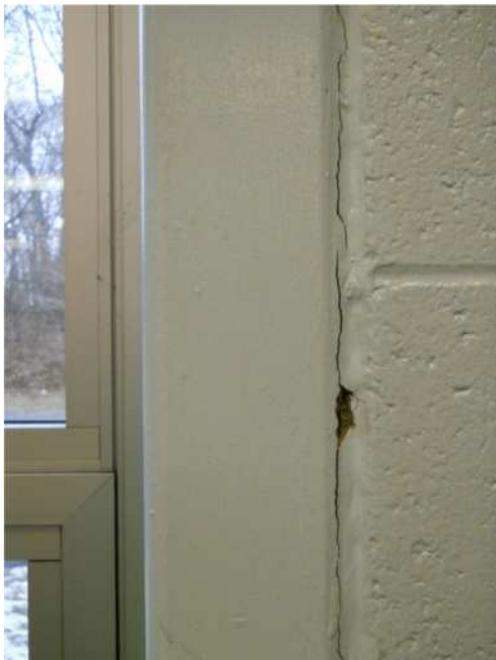
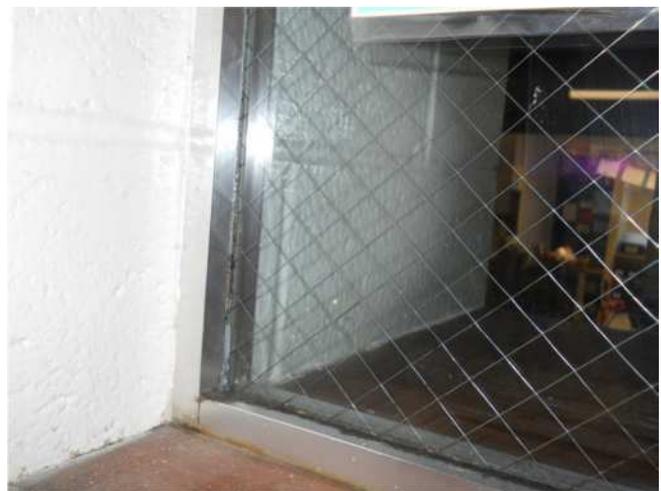
Photos of typical building sealants observed during the building survey are provided below.

- Caulking and glazing sealants were observed throughout the building, primarily associated with window and door systems and expansion joints; the majority of the sealants were observed to be intact and pliable; given the dates of construction of the building, these materials are considered suspect for PCBs.

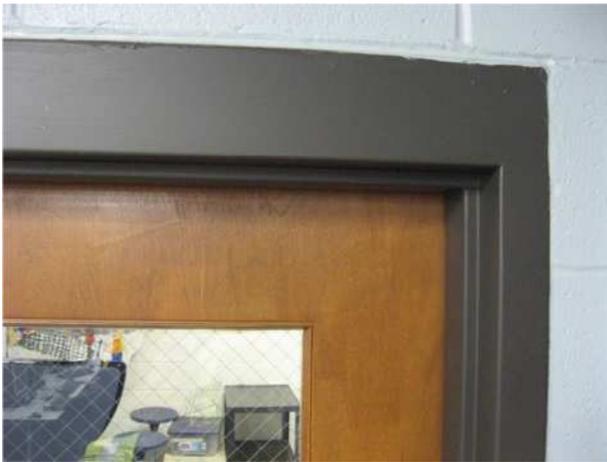
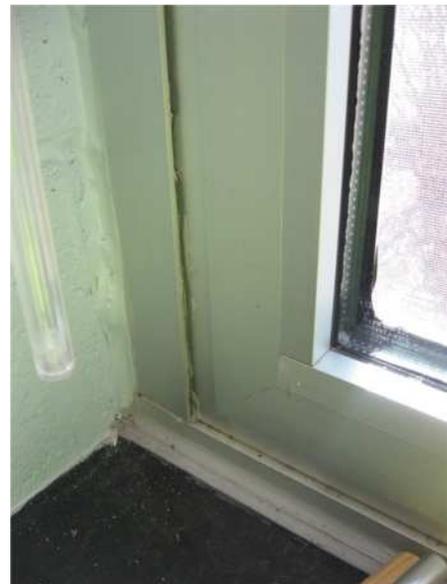
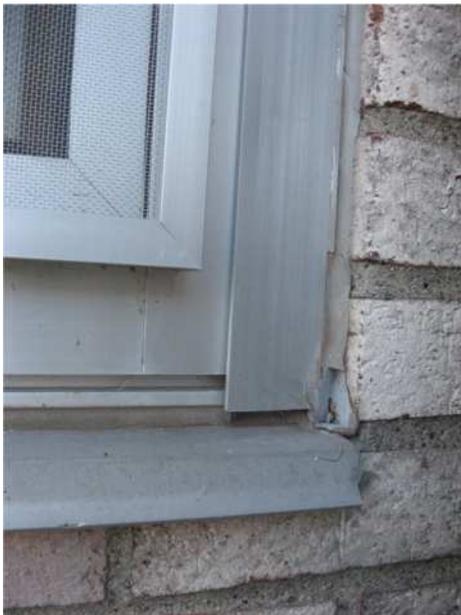
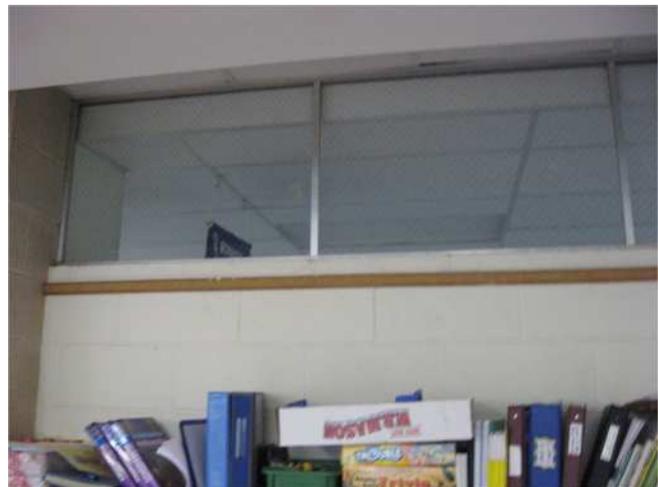
Photos of typical building sealants observed during the building survey are provided below.

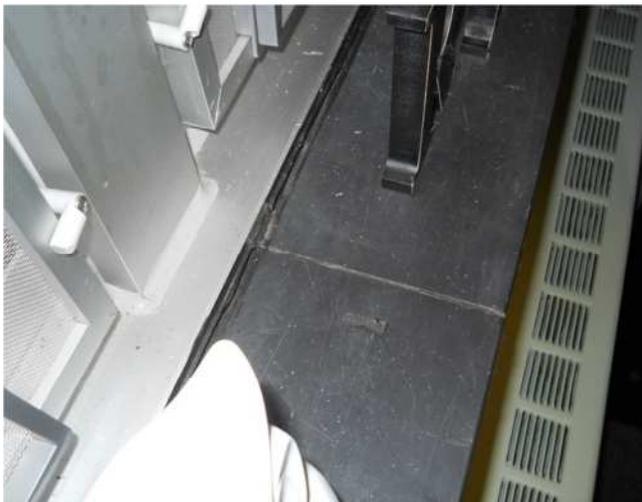
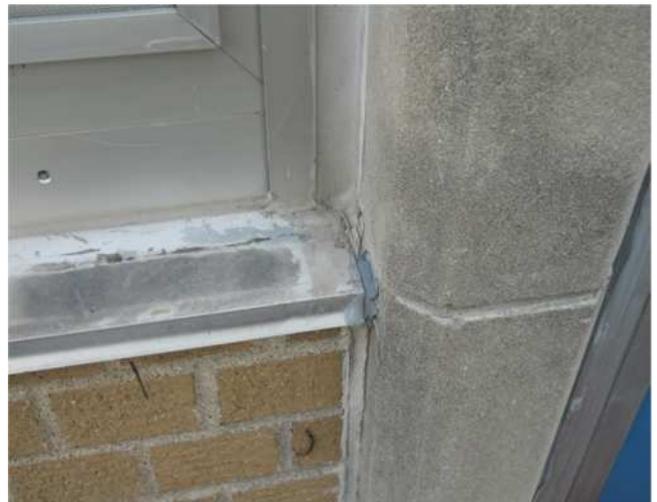
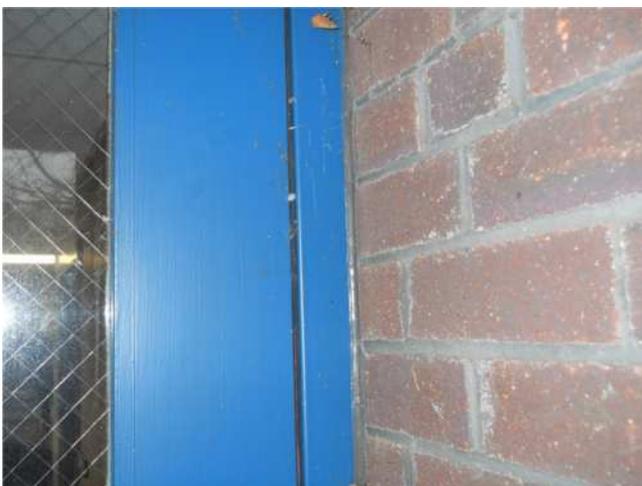
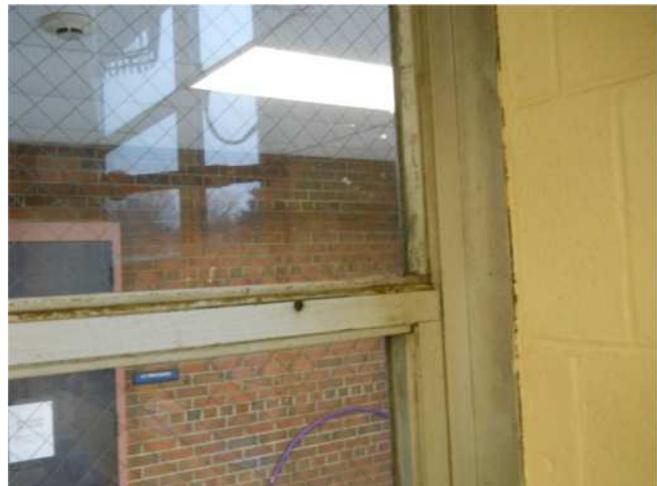
Photos of typical building sealants observed during the building survey are provided below.

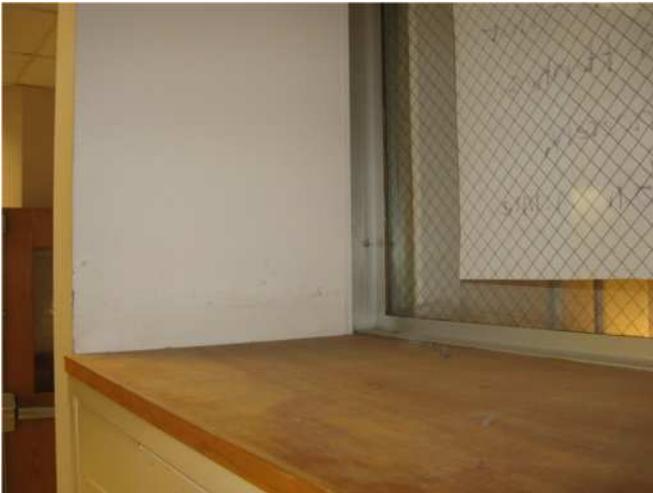
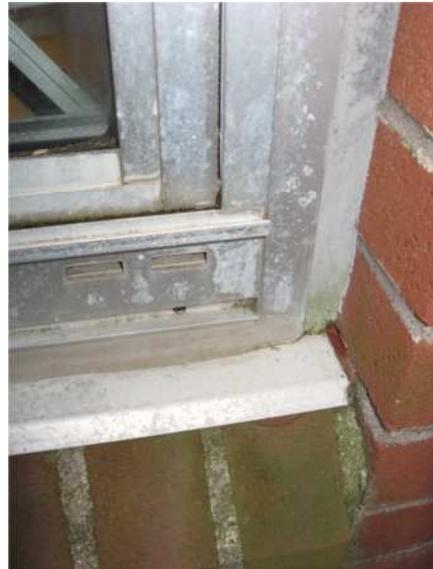
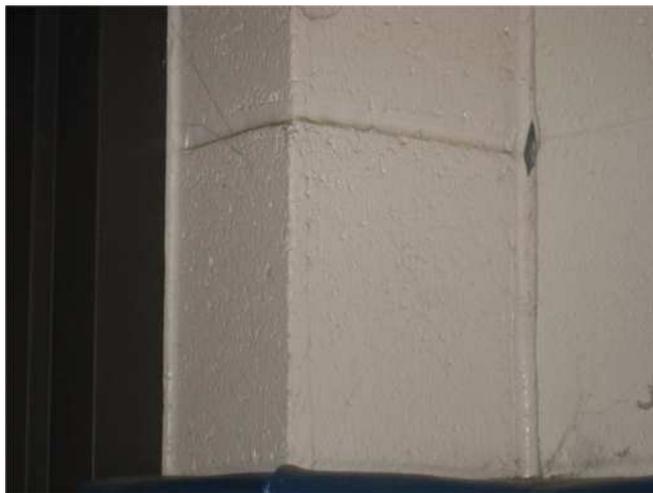
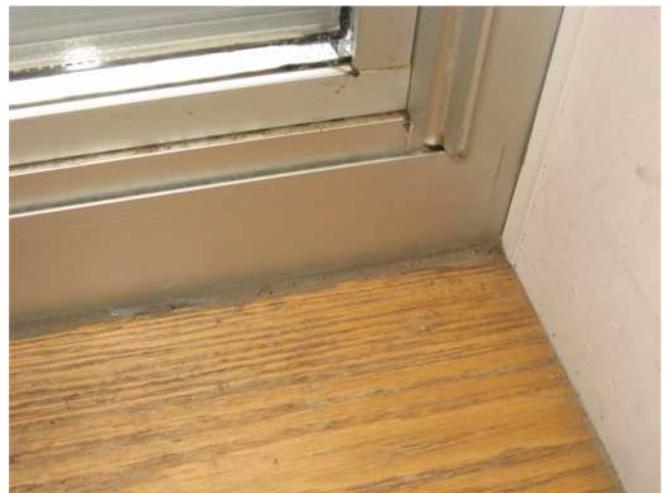
Photos of typical building sealants observed during the building survey are provided below.

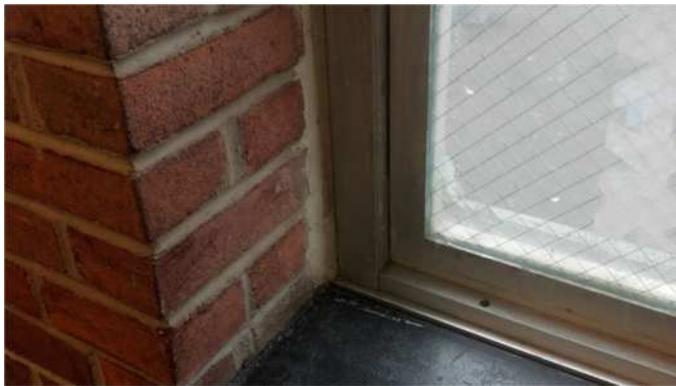
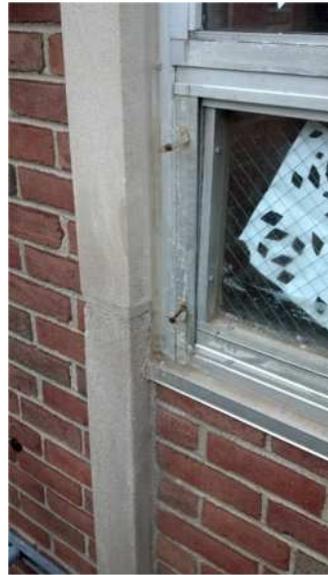
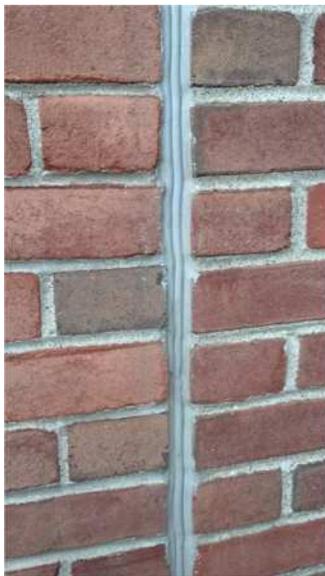
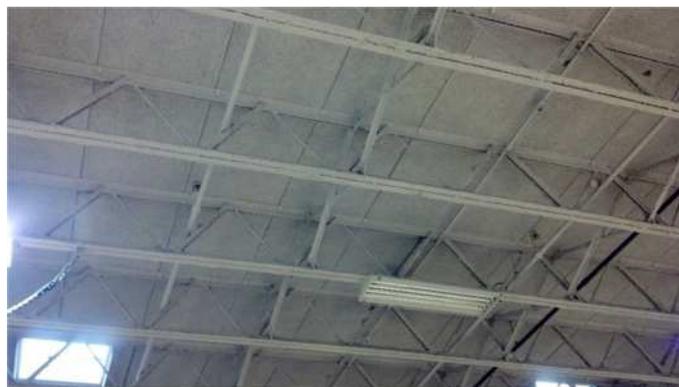
these specialty paints are typically not specified for use in school building settings). During the building survey various caulking and window glazing sealants were observed most notably gray and white caulking along the interior and exterior window frames; painted-over sealants along door frame to CMU joints, and sealants at brick to brick/CMU joints along the building exterior. The gymnasium was observed to have tectum ceiling panels and spray-on fireproofing.

Photos of typical building sealants observed during the building survey are provided below.

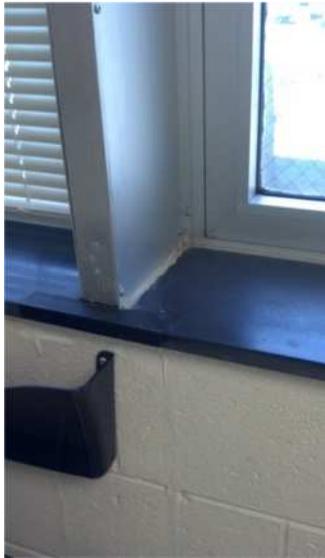
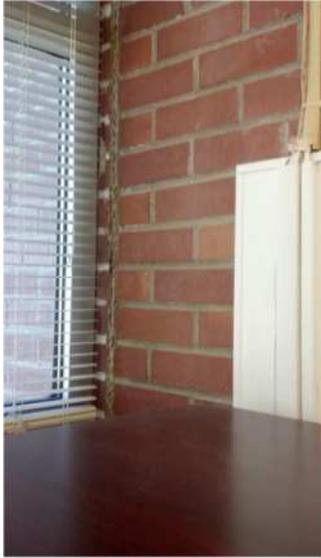
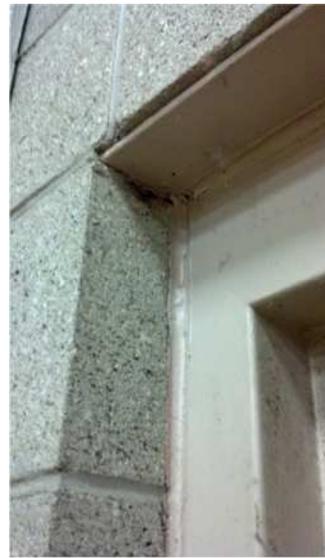
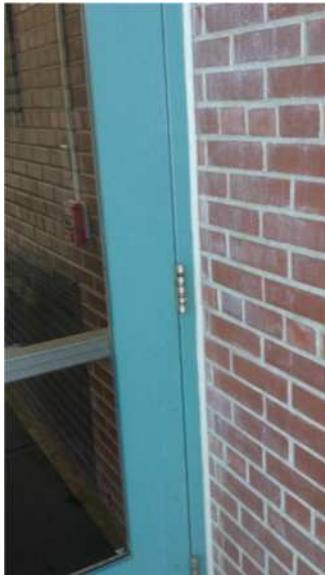
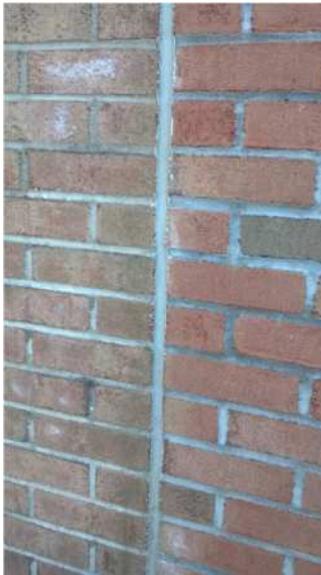
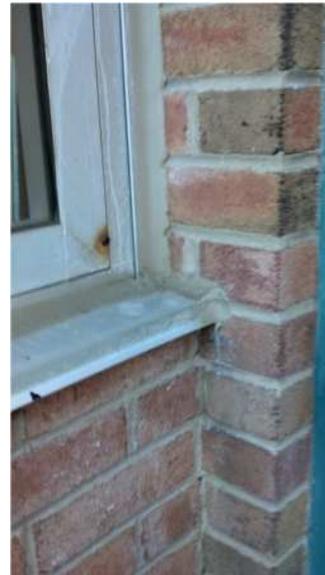
Presence of Primary Suspect Materials – In typical school building settings, primary building materials that may have been manufactured with PCBs and could be accessible predominantly include caulking and sealants (NOTE – although some specialty paints have been known to be manufactured with PCBs, these specialty paints are typically not specified for use in school building settings). During the building survey various caulking and window glazing sealants were observed most notably gray and white caulking along the interior and exterior window frames; painted-over sealants along door frame to CMU joints, and sealants at brick to brick/CMU joints along the building exterior.

Photos of typical building sealants observed during the building survey are provided below.

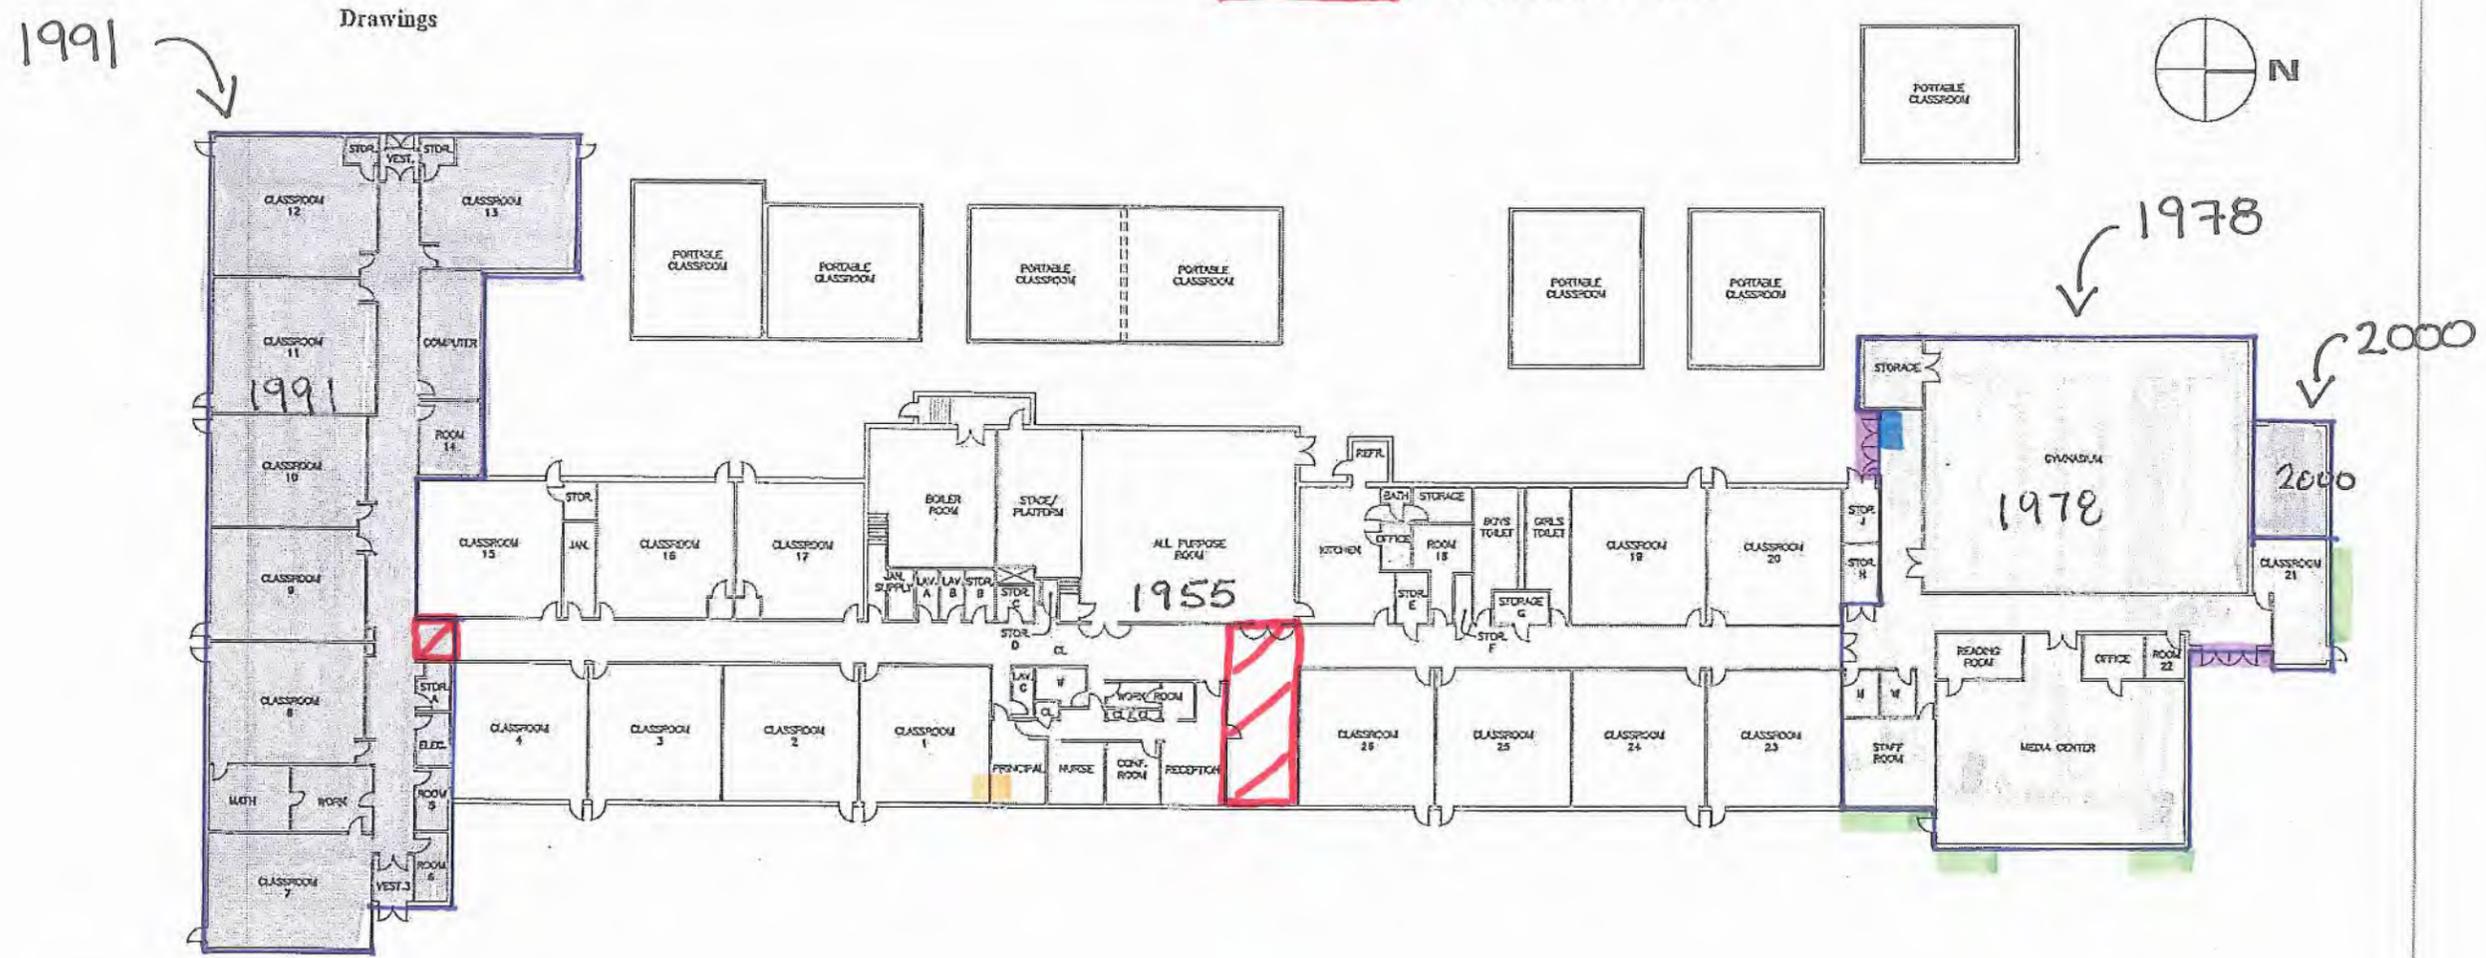
FLOOR PLAN
SCALE: 1/32" = 1'-0"

- Type 1 - Interior brick to brick vertical joint (principal's office)
- Type 2 - Interior glazing sealant (glass to door frame joints)
- Type 3 - Exterior window frame joints (1978 portion)
- Type 4 - Exterior door frame joints (1978 portion)
- Tile Sealer/Finisher

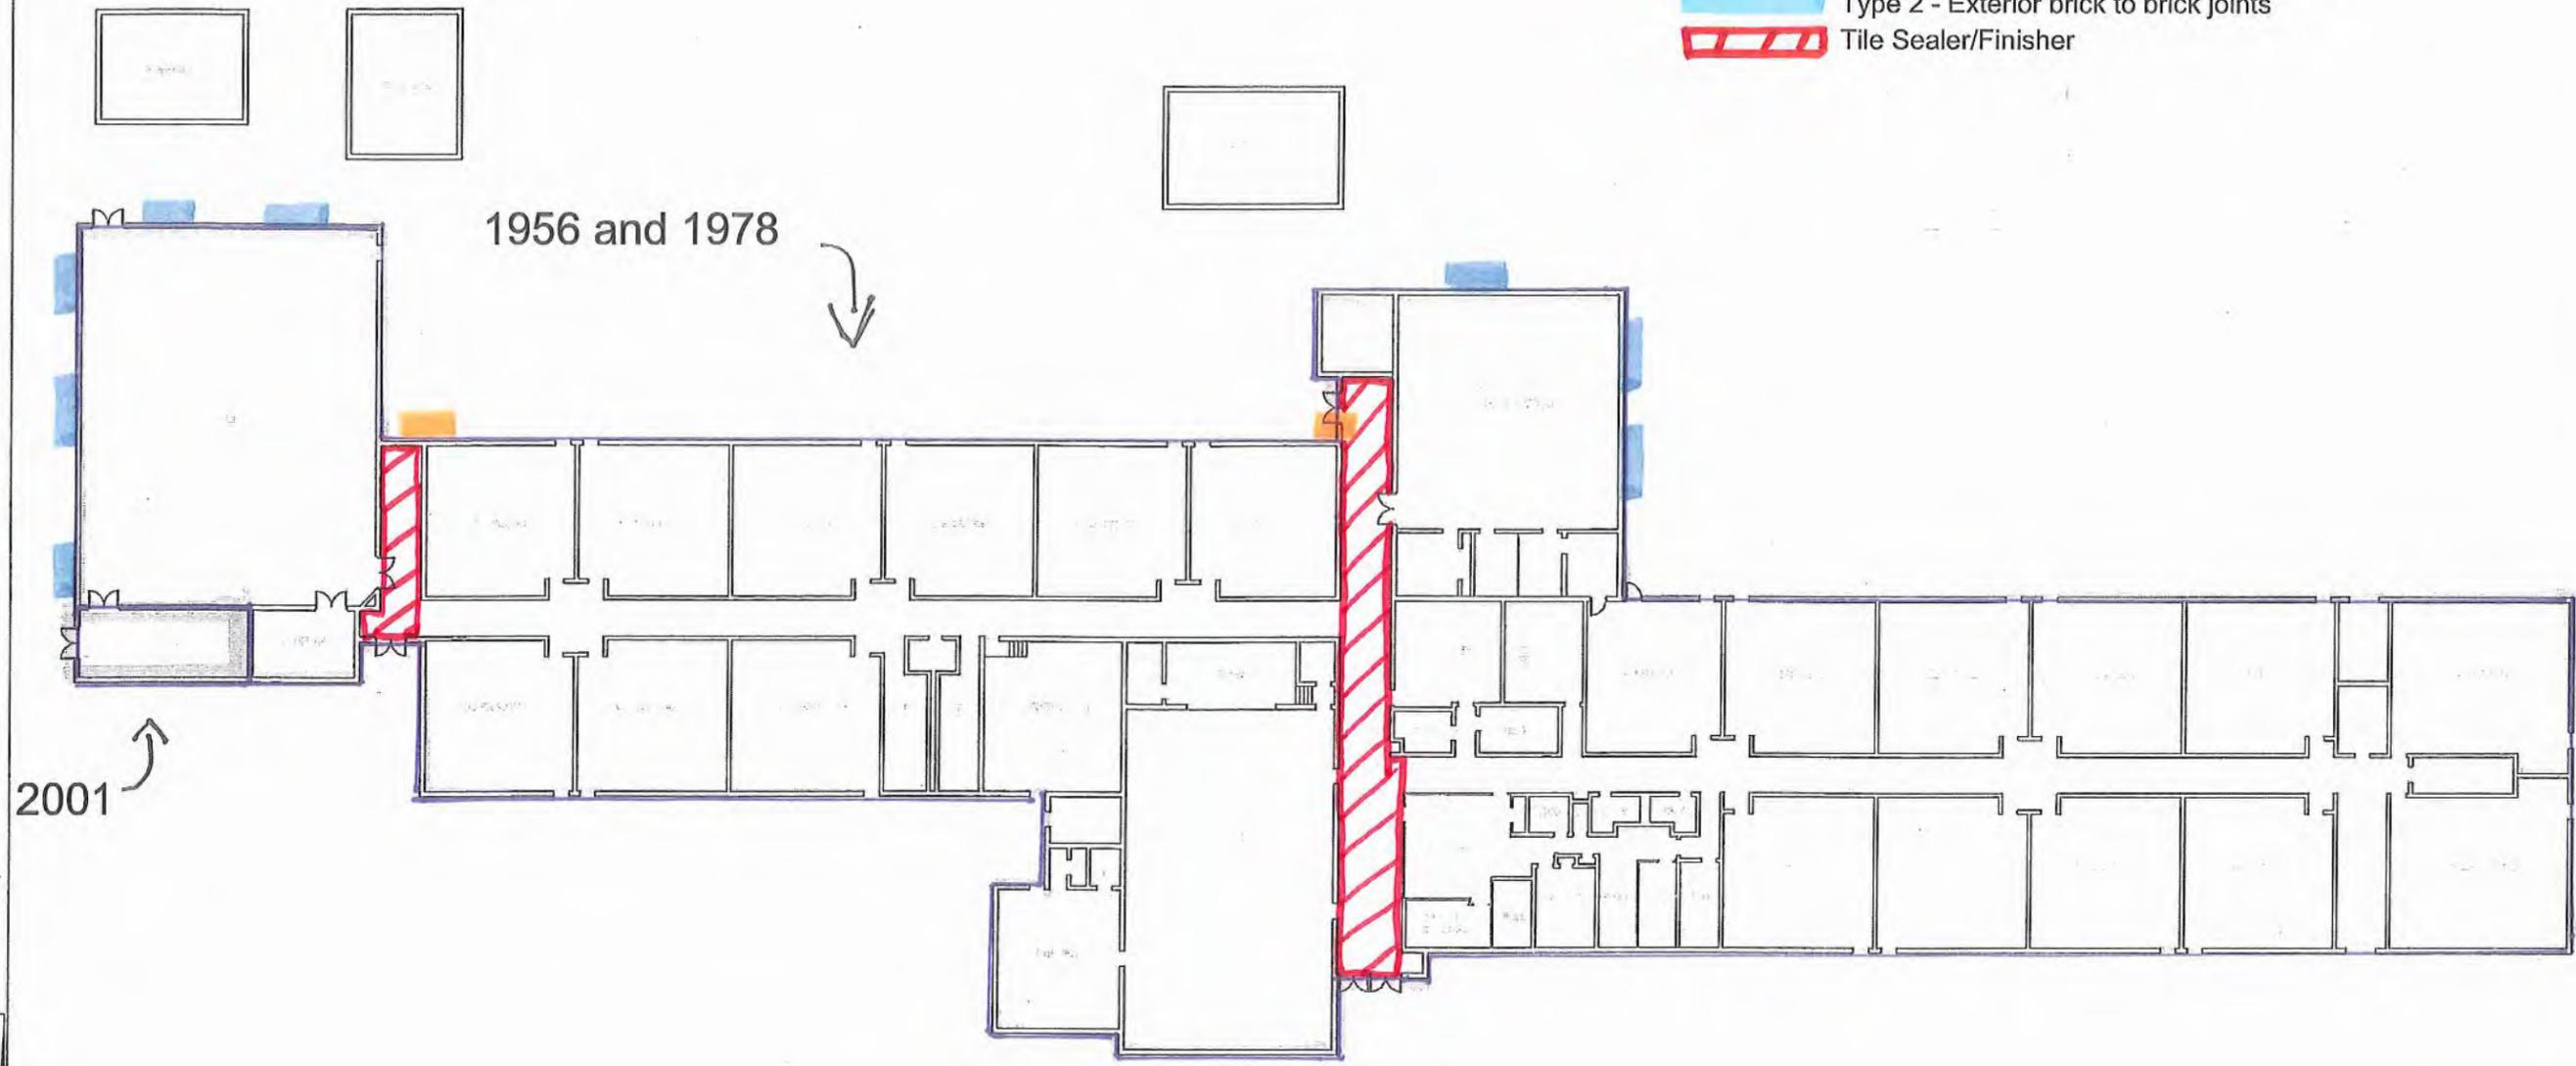
HOLLAND HILL ELEMENTARY SCHOOL

- Type 1 - Exterior door frame to brick joints
- Type 2 - Exterior brick to brick joints
- Tile Sealer/Finisher

Other								
Tile Sealant/Finisher	N/A	N/A	Interior	Clear tile sealant/finisher applied to stone tile in select areas of the building. Coating is in good physical condition with no areas of flaking or cracking observed.	Main entrance hallway and hallway adjacent to gymnasium	Low	Conduct periodic visual inspection to check for damage or deterioration of applied coatings (applied annually). Reapply as needed.	Coating applied annually as part of standard building maintenance to be used as interim measure.

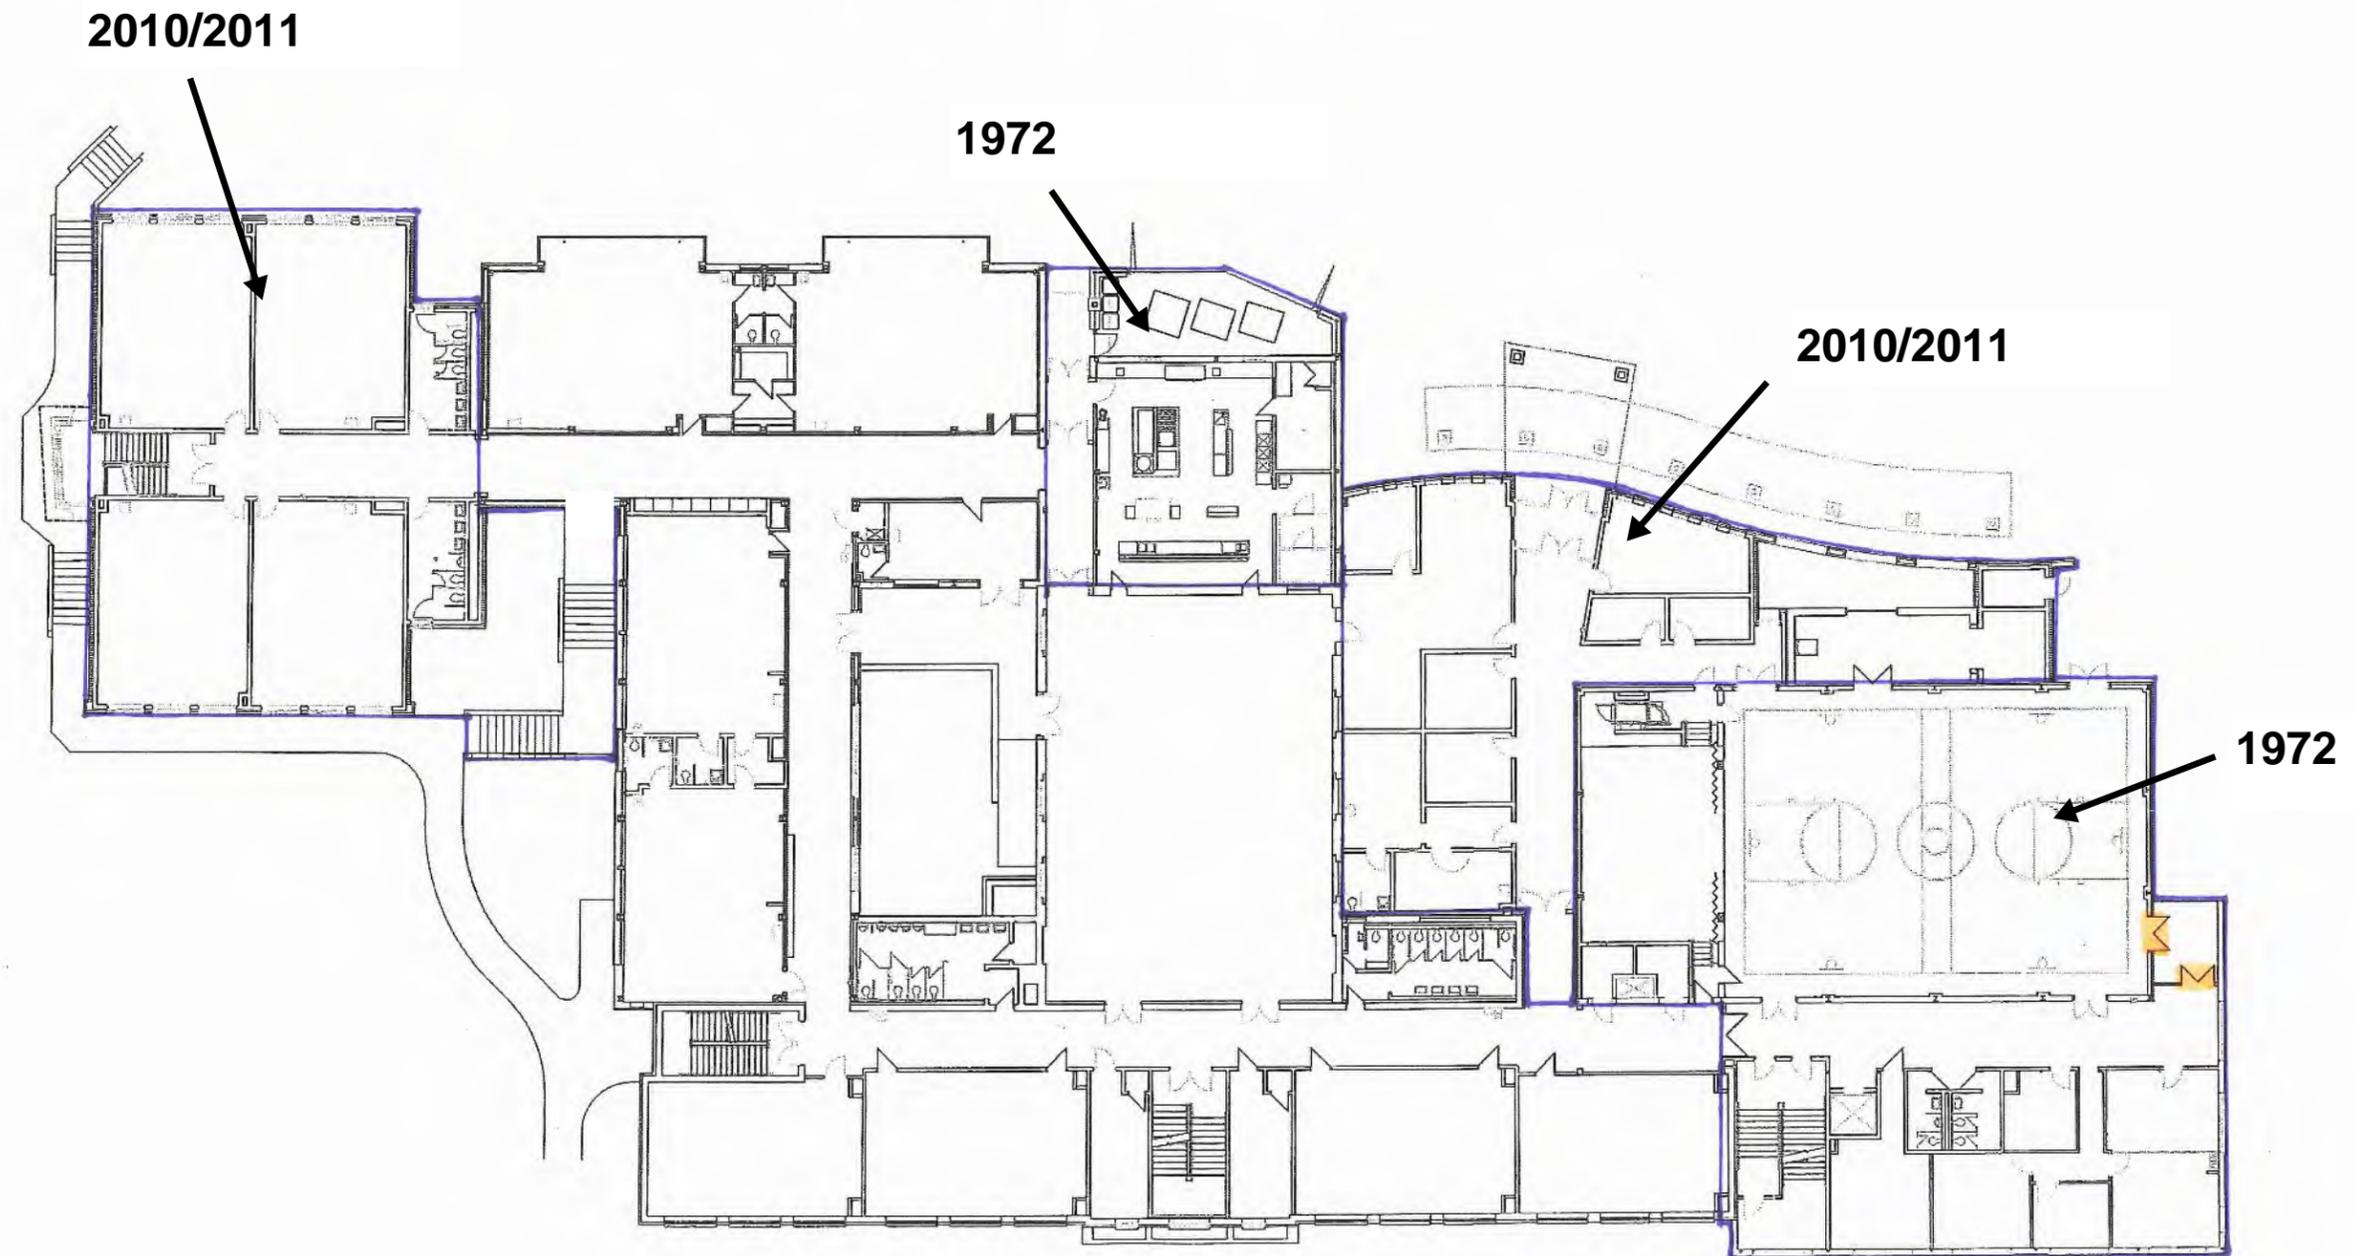
STRATFIELD ELEMENTARY SCHOOL MAIN LEVEL

Type 2 - Exterior door frame to concrete joints (1972 portion)

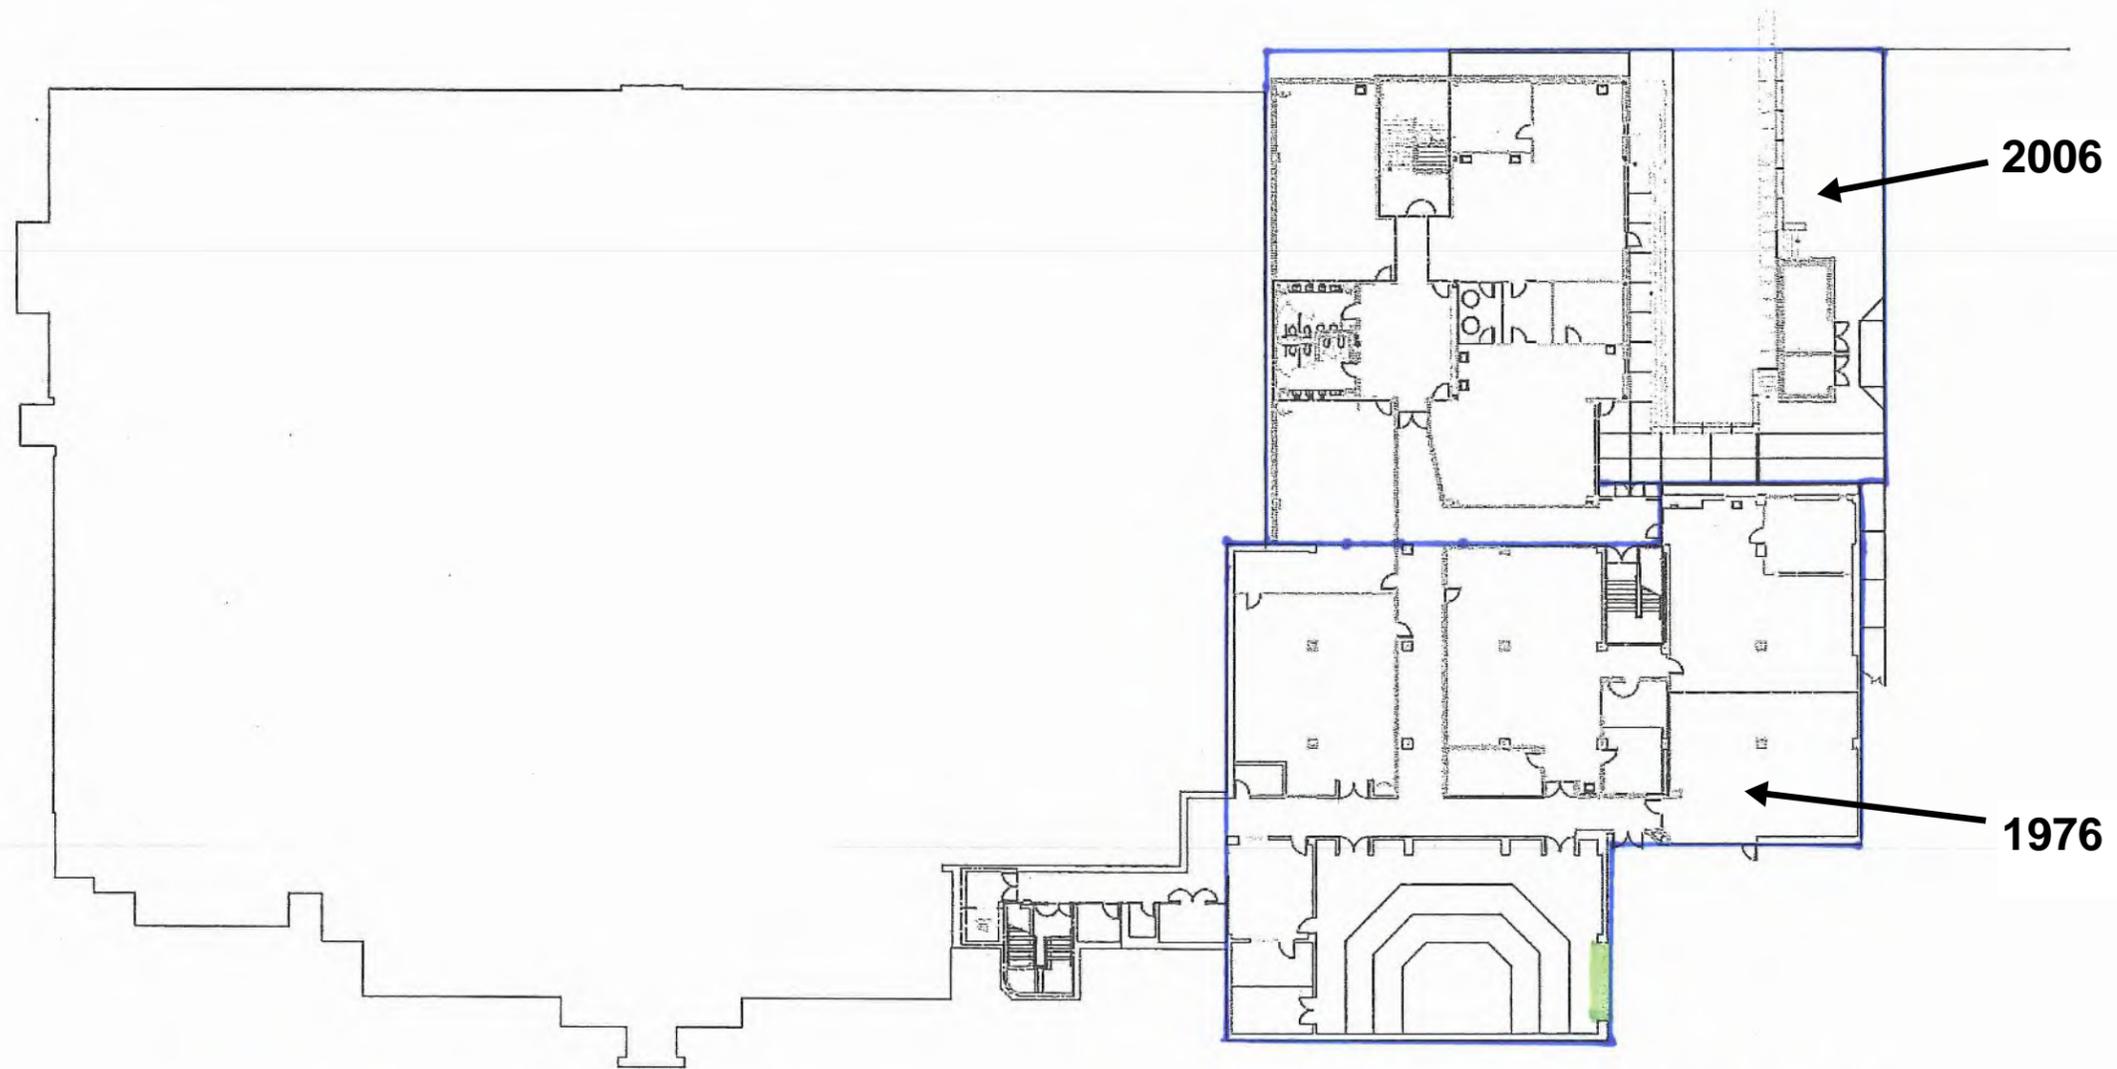
TOMLINSON MIDDLE SCHOOL

Type 3 - Exterior brick to brick wall joints and brick to door frame joints (gymnasium)

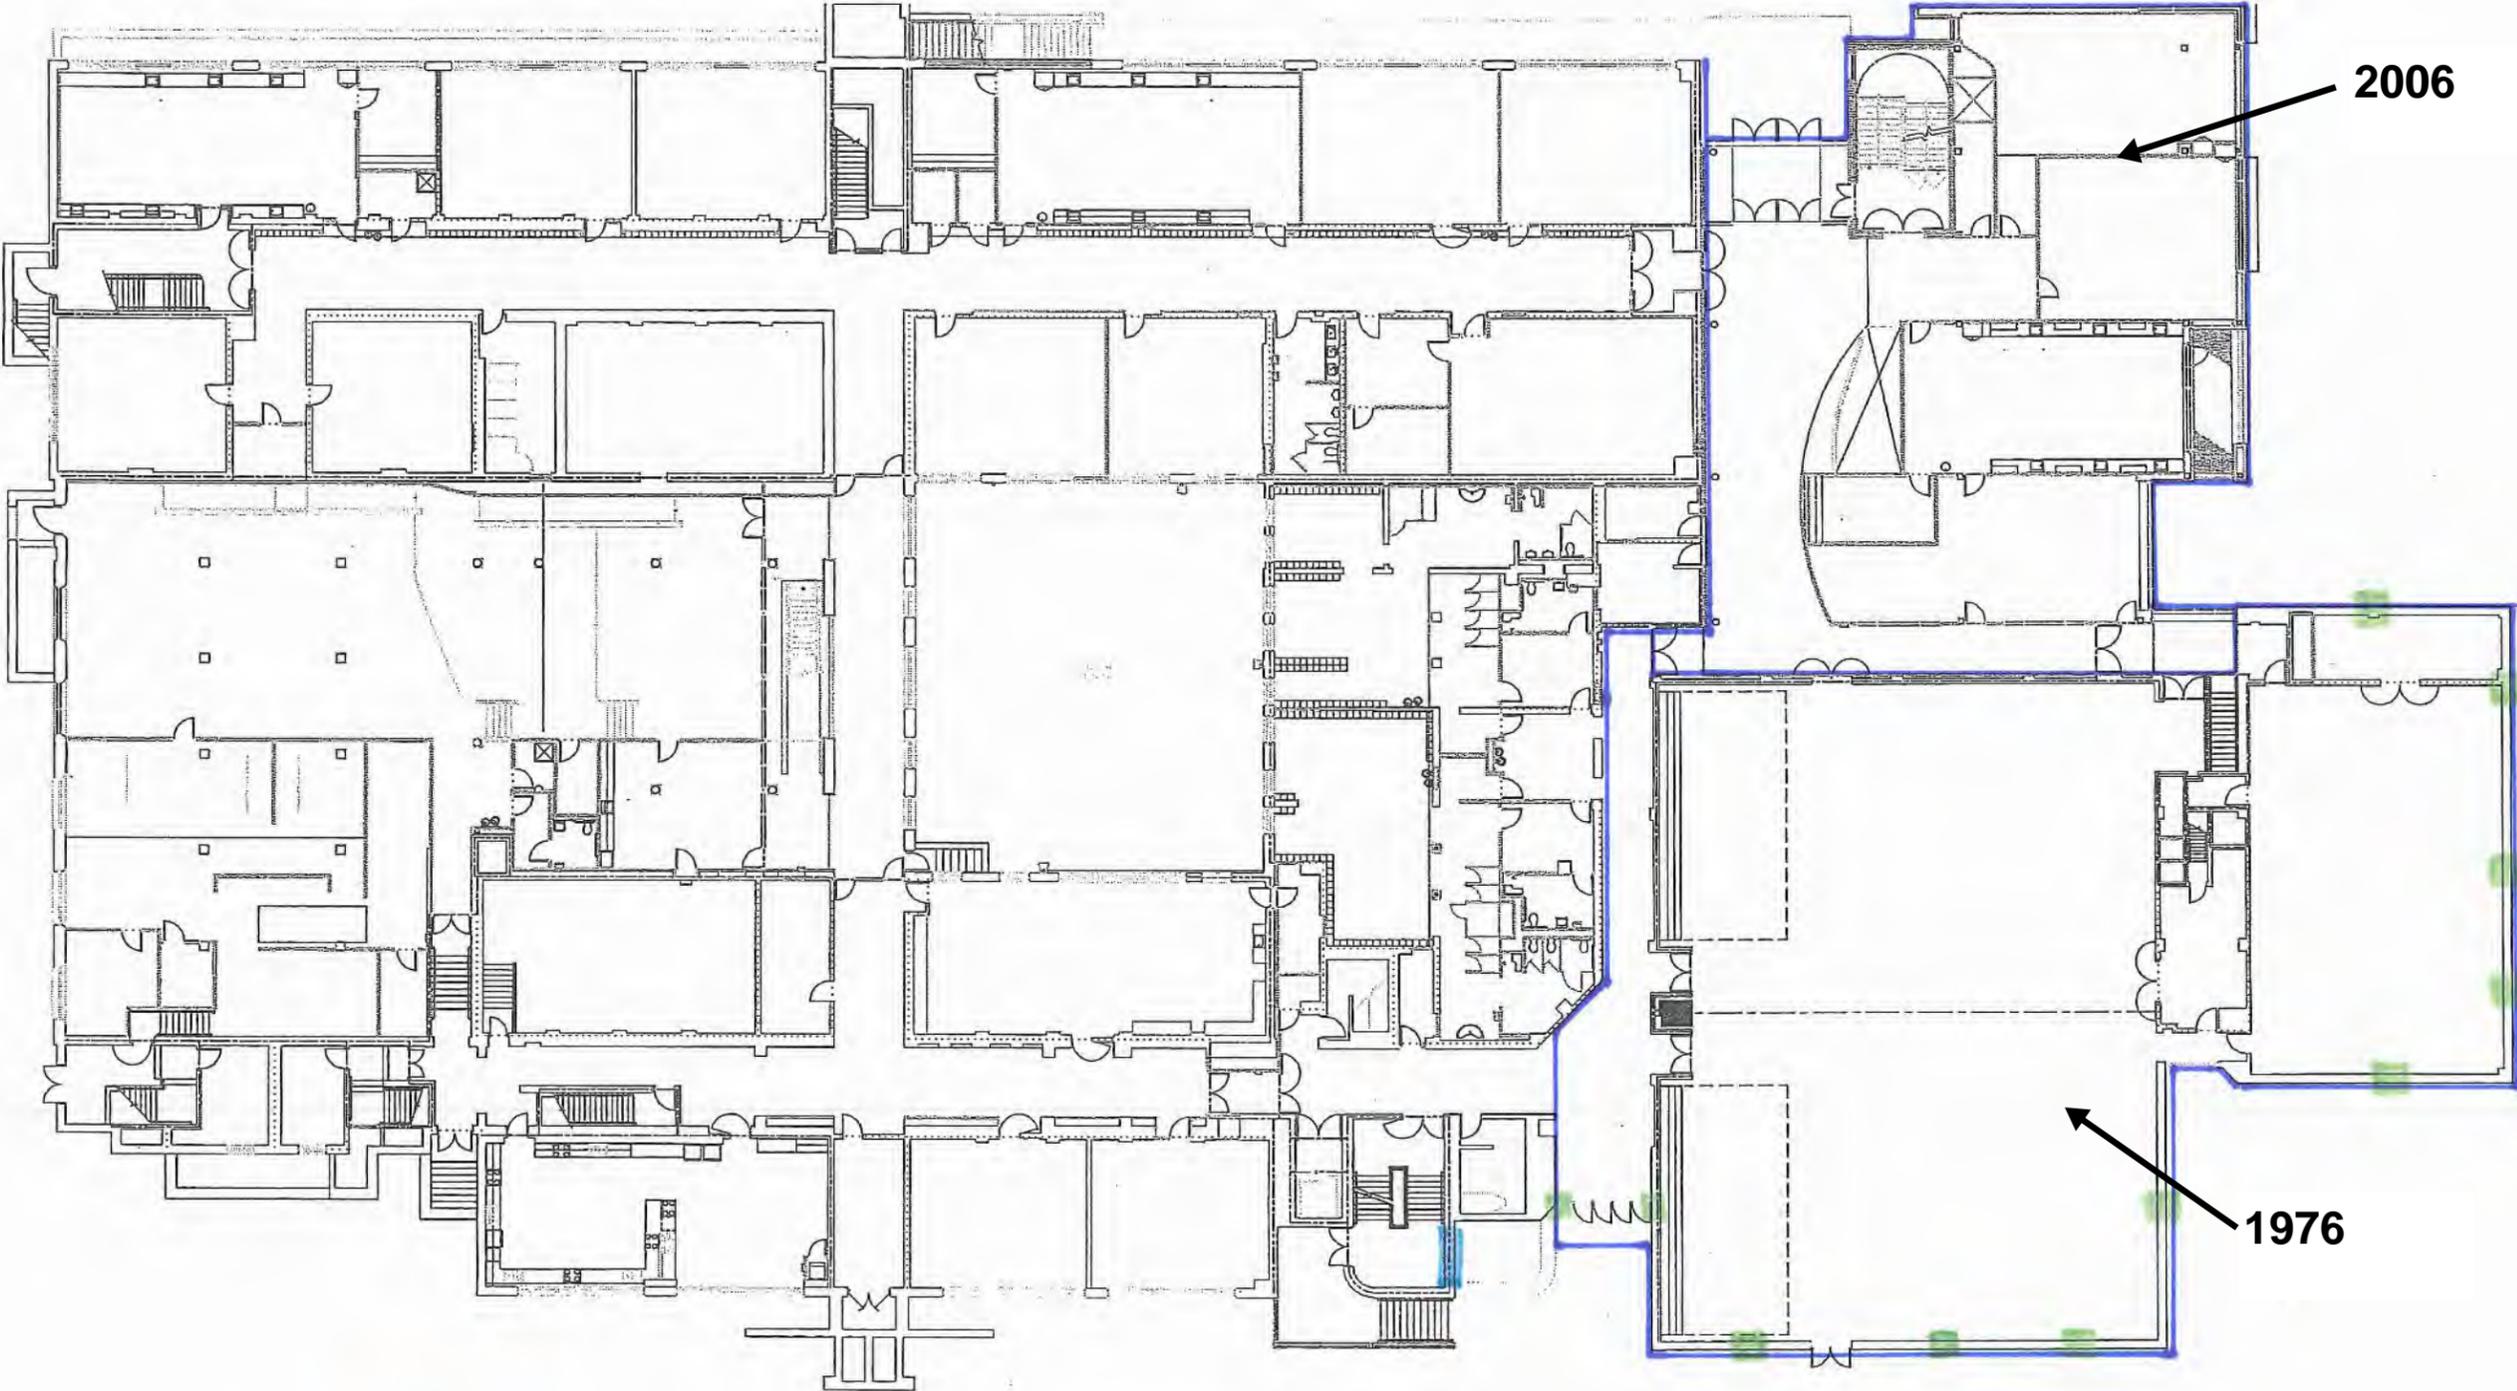
TOMLINSON MIDDLE SCHOOL

- Type 2 - Interior window frame to CMU wall joints (Stairwell # 4 window)
- Type 3 - Exterior brick to brick wall joints and brick to door frame joints (gymnasium)
