Fairfield Public Schools
Fairfield, CT 06825

RE: Woodard and Curran Follow-up Assessment Report

Re: **Follow-up Building Surveys**
Fairfield Public Schools

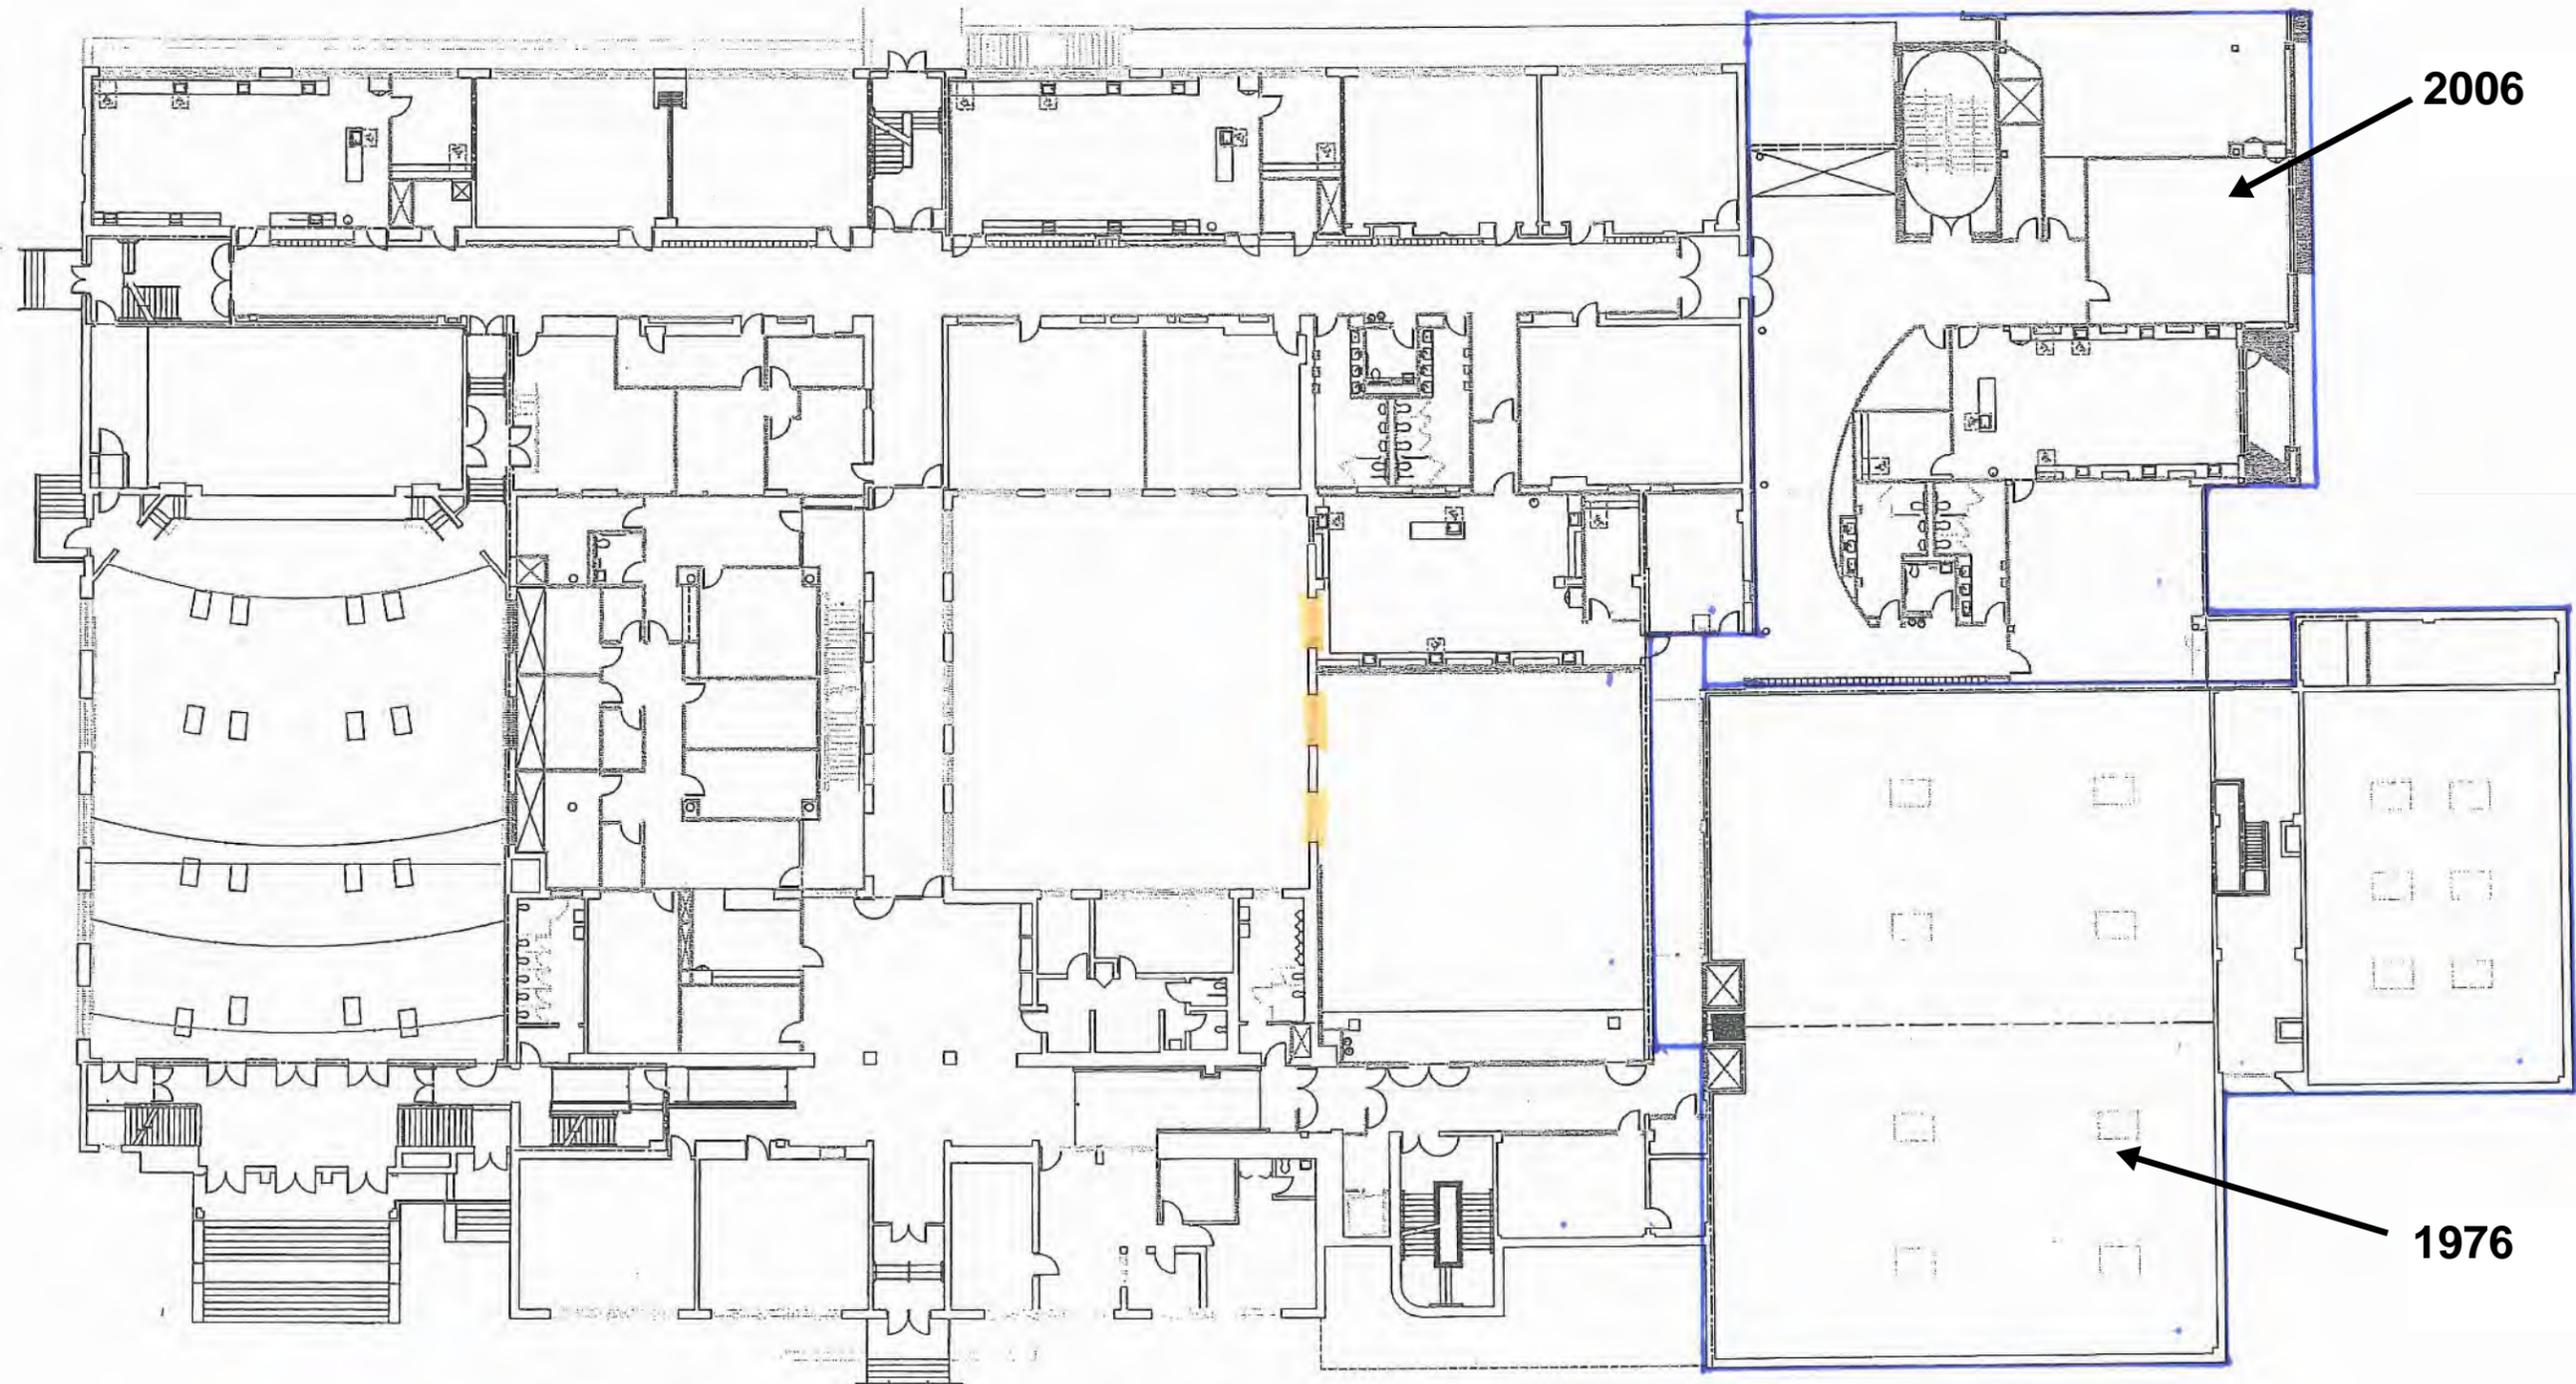
TOMLINSON MIDDLE SCHOOL

Type 1 - Interior window frame to brick joints (arched windows)

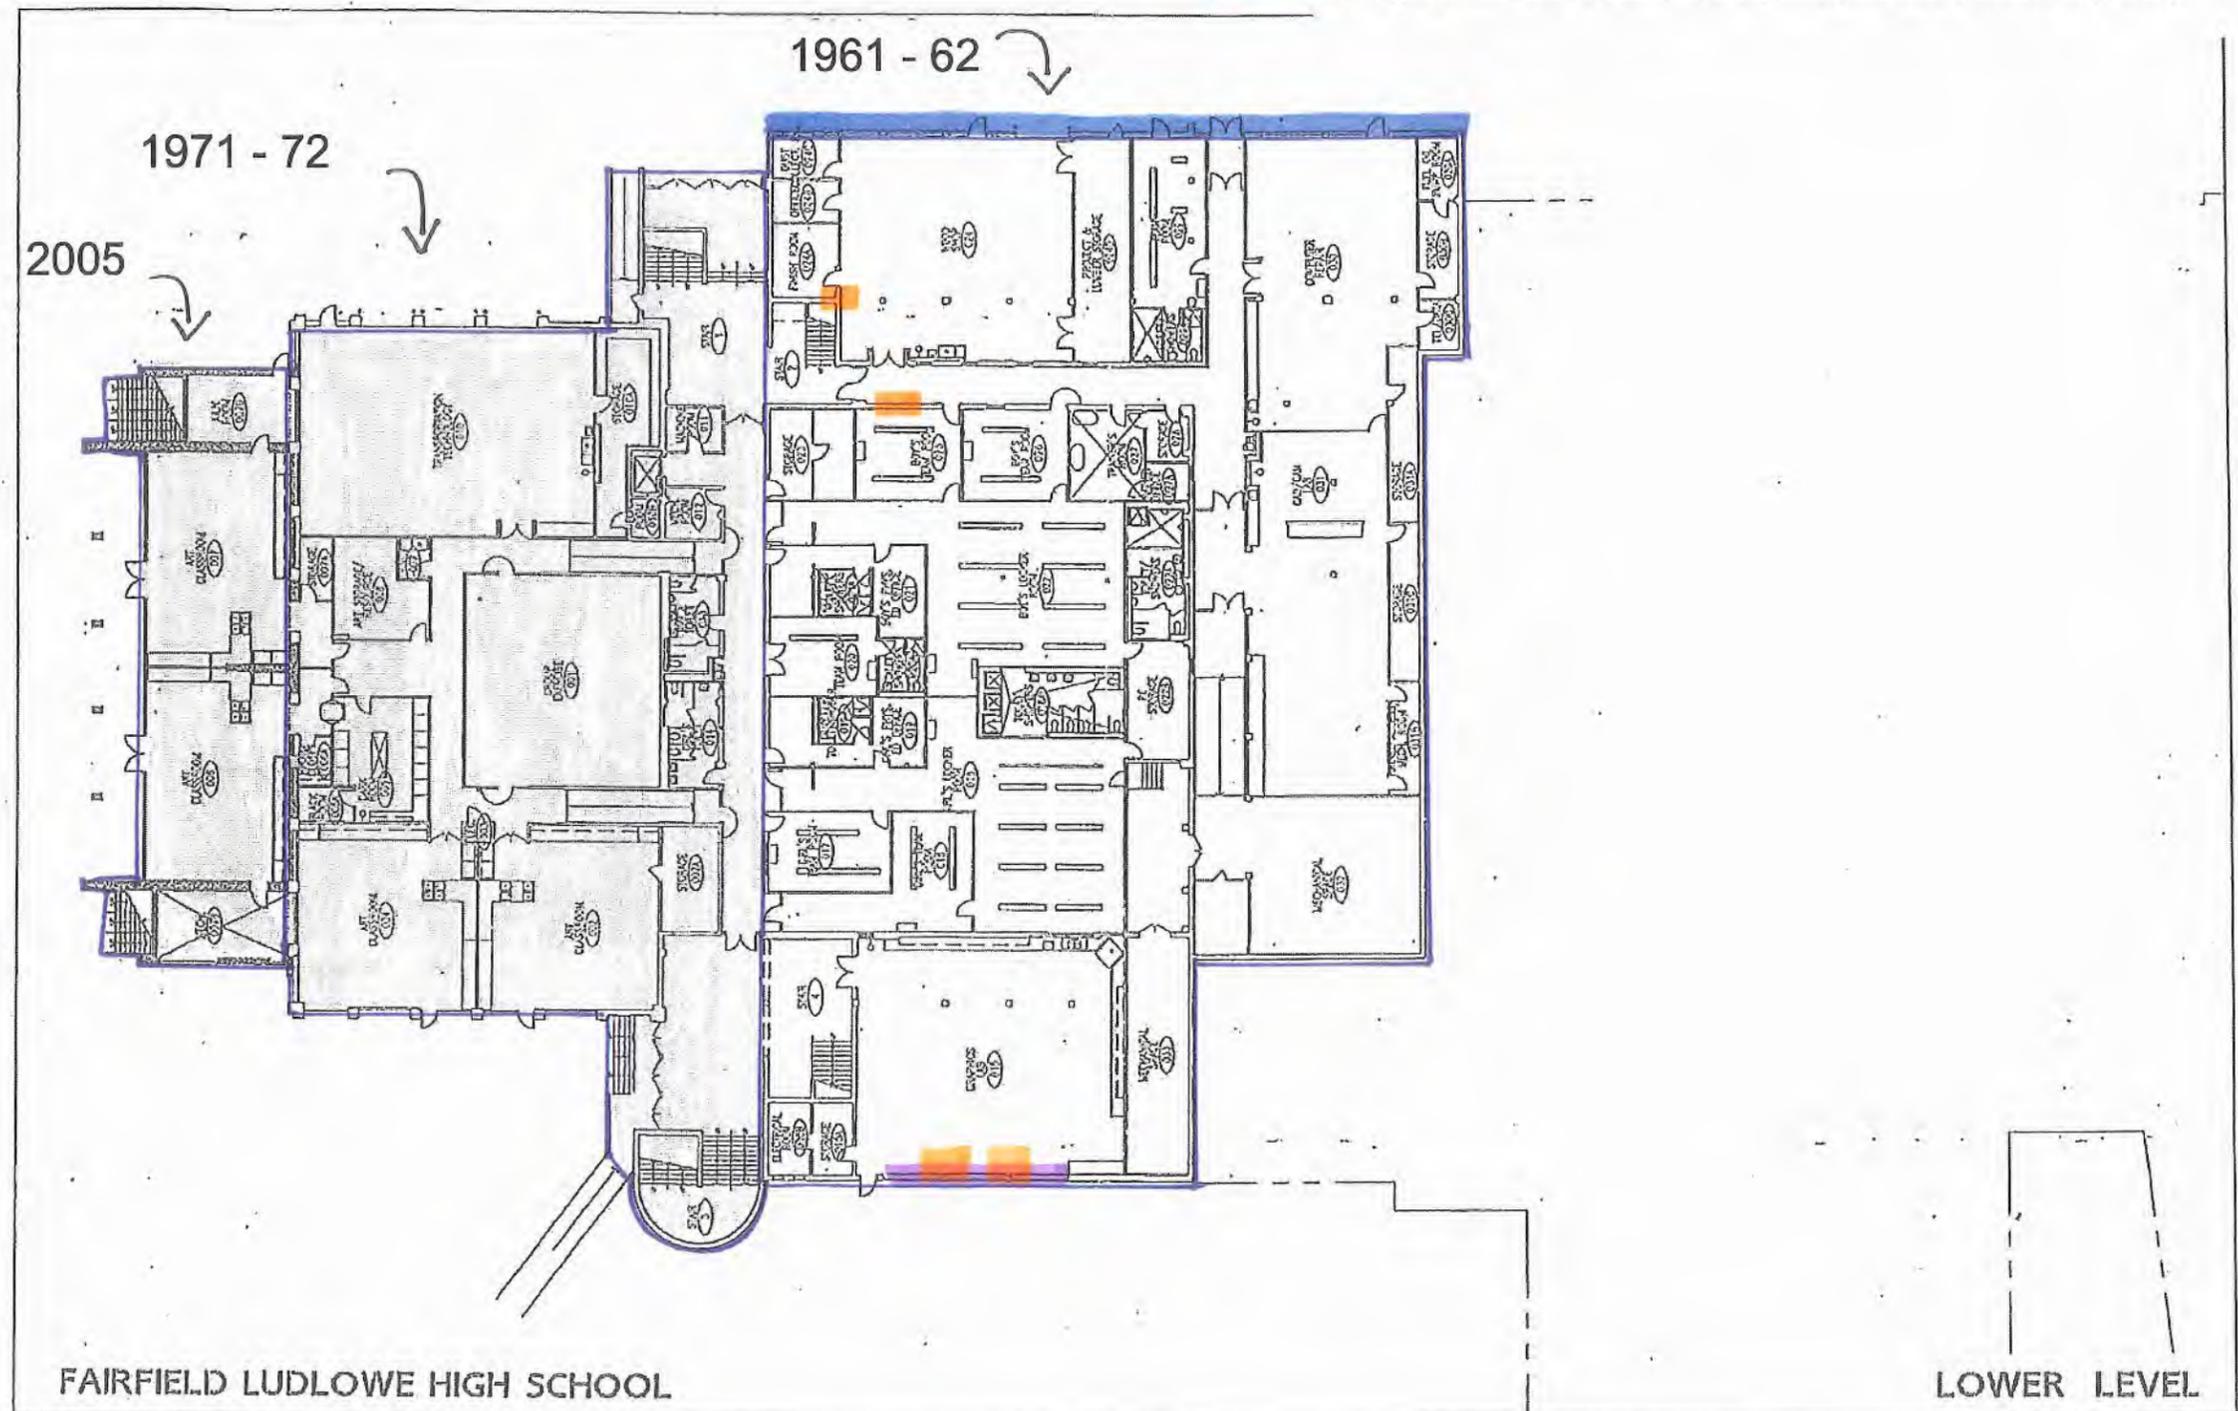
FAIRFIELD LUDLOWE HIGH SCHOOL

- Type 1 - Interior CMU to steel and window frame joints (1961/62 portion)
- Type 4 - Interior and/or exterior window frame joints and/or glazing sealants (pre-2005 portions)
- Type 5 - Exterior window frame joints (1961-62 portion shop area)

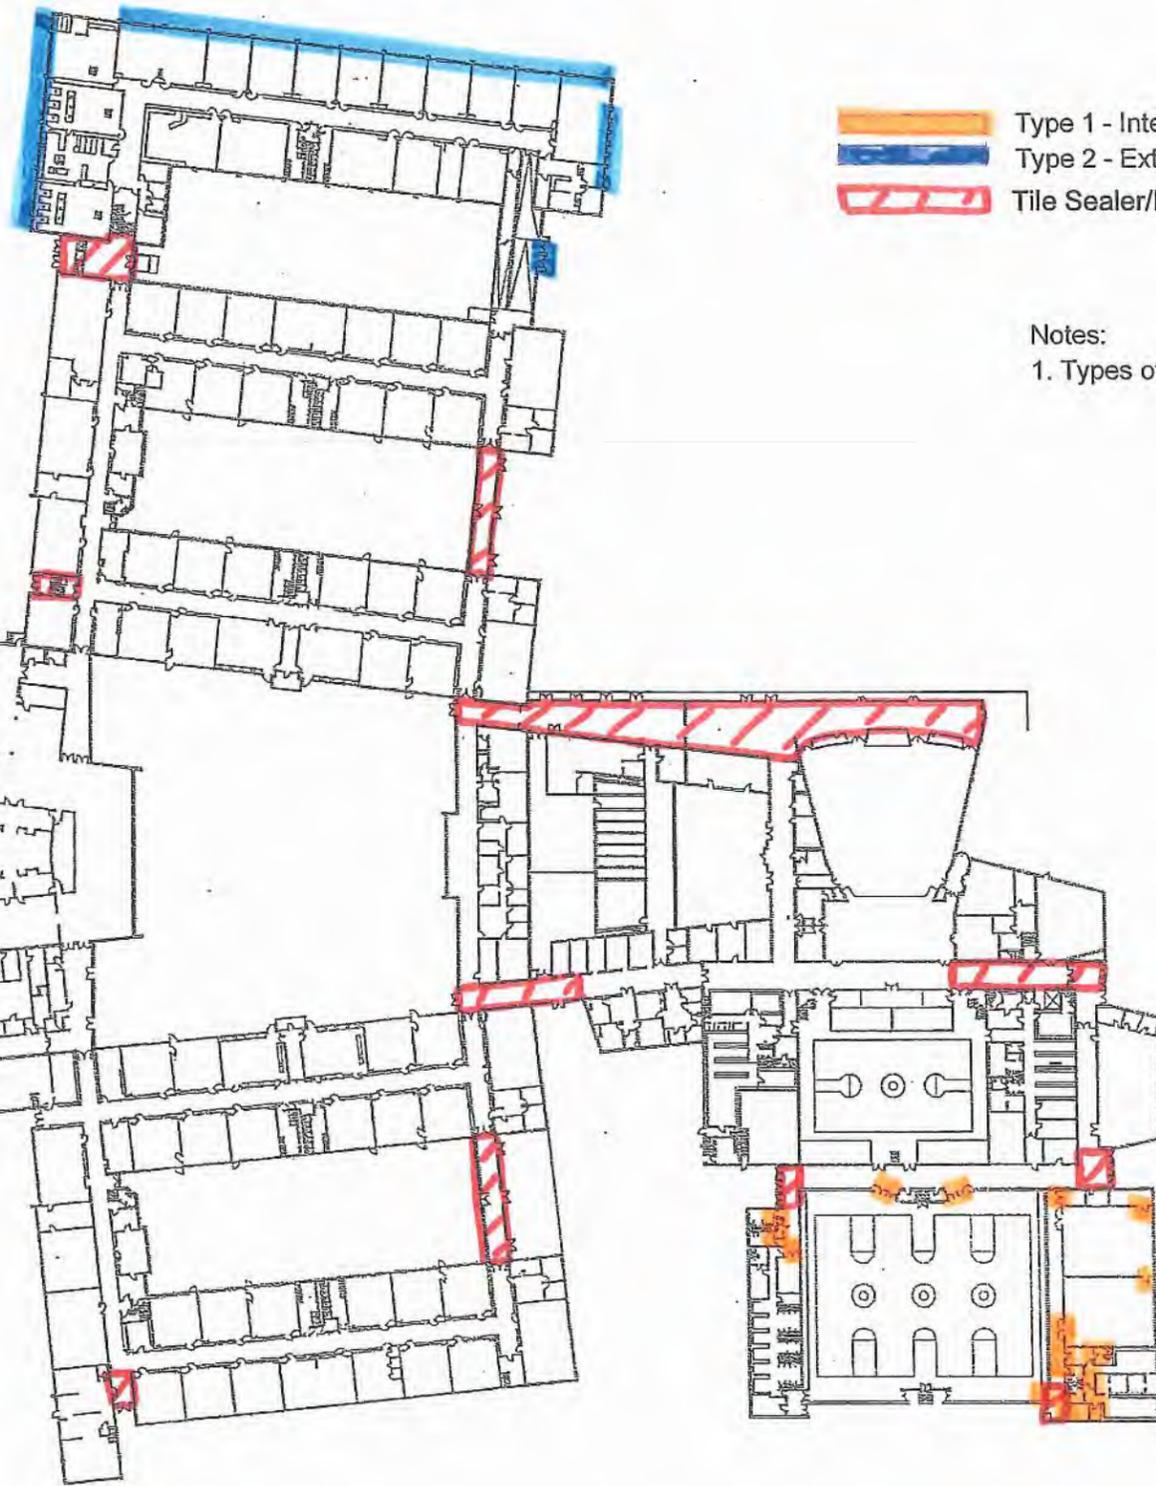
FAIRFIELD WARDE HIGH SCHOOL

- Type 1 - Interior Door frame joints (gymnasium area)
- Type 2 - Exterior door and window perimeter joints (1st and 2nd floors)
- Tile Sealer/Finisher
