RE: Woodard and Curran Assessment Report

Re: Assessment of PCBs in Building Materials – School Buildings
Fairfield Public School District

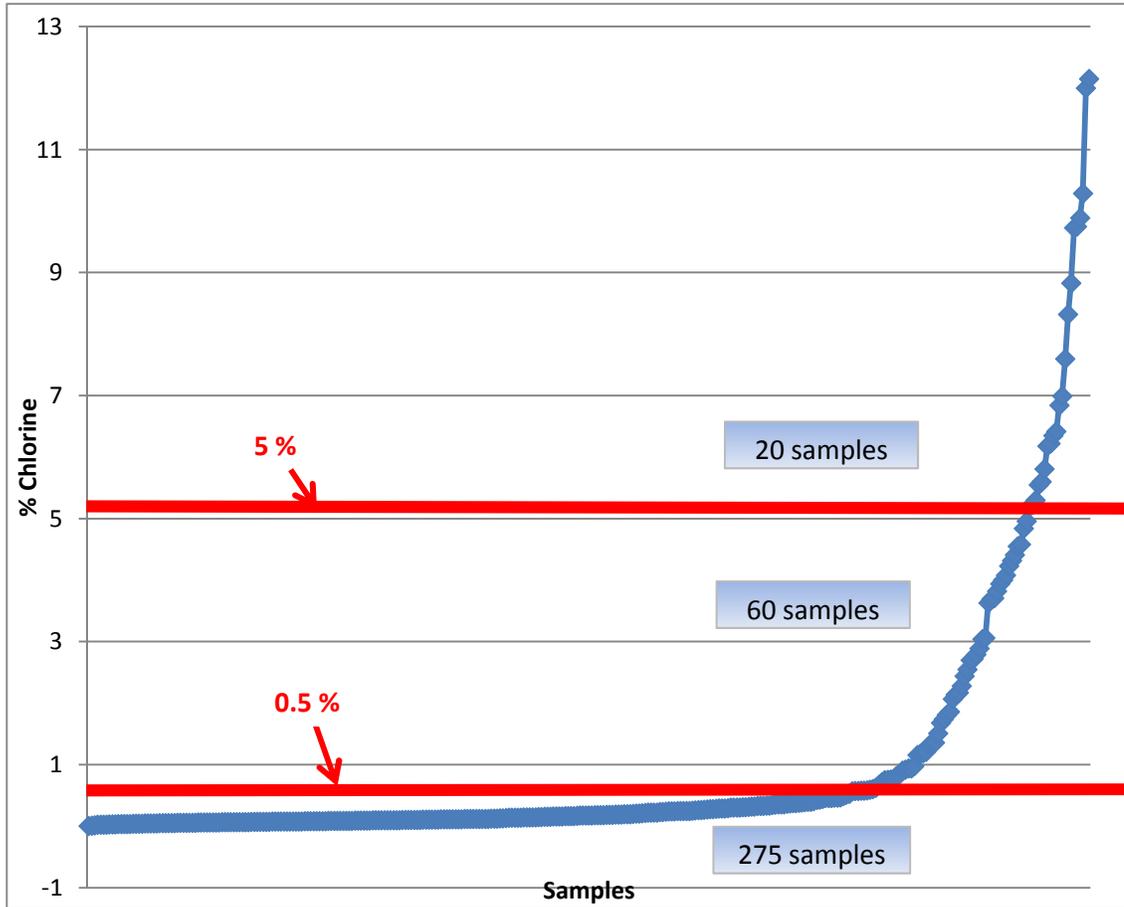
As part of the Fairfield School building surveys, 355 samples of suspect building materials were collected and field screened for chlorine. On average, about 27 samples of different materials were collected from each of the 13 buildings and screened with the XRF meter. A plot of the % chlorine levels in these samples is provided in the chart below.

As shown above, the majority (275 samples or 77%) of the Fairfield school samples were reported with chlorine levels below the 0.5% correlation level that typically corresponds to PCBs < 50 ppm. Sixty samples (17%) were reported in the 0.5 to 5% inconclusive range and 20 samples were above 5%.

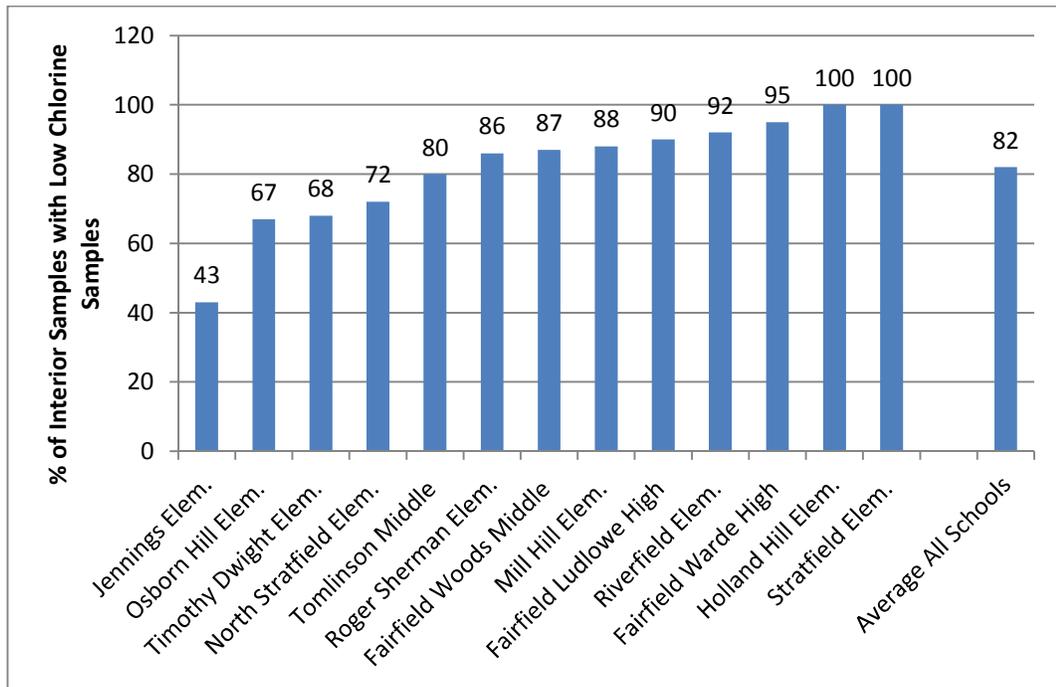
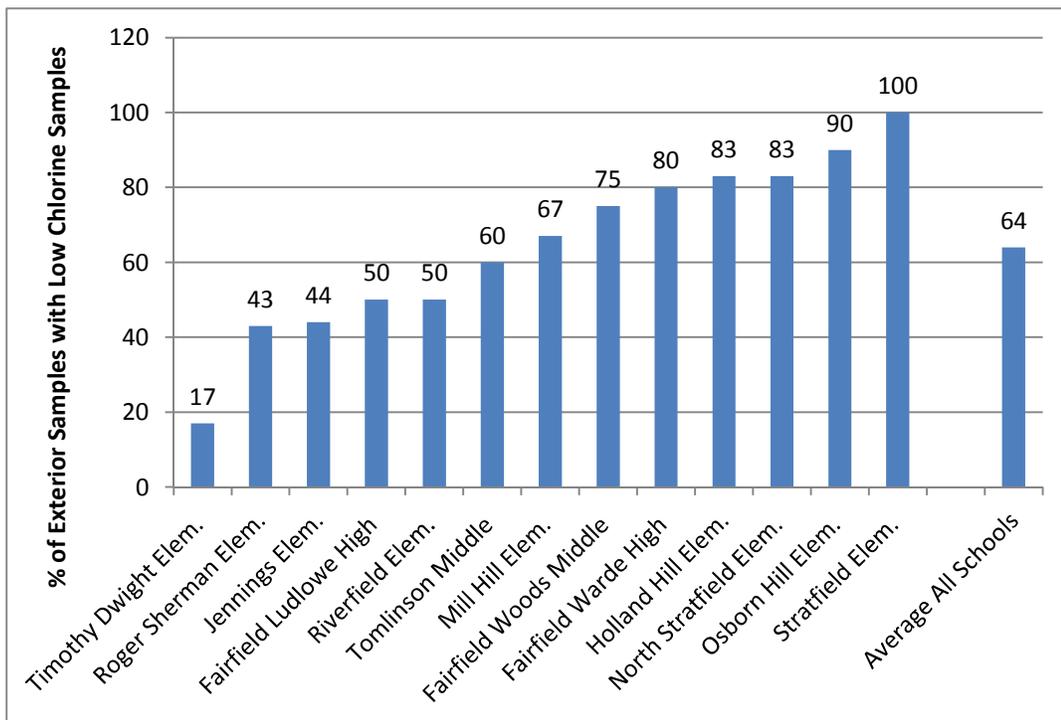
A further summary of the individual building survey screening results for interior and exterior samples, respectively as a % of samples per building which were below the 0.5% level is presented on the charts below.

As indicated on the charts above, approximately 82% of the interior samples and 64% of the exterior samples collected from the schools were below the 0.5% screening level. The charts also indicate that a higher percentage of screening levels above 0.5% relative to the “average” were found in five schools (interior samples) and six schools (exterior samples). Three schools were on both lists: Jennings Elementary, Timothy Dwight Elementary, and Tomlinson Middle. A summary of the screening results for each of the buildings is presented in Appendix B.

- Follow-up evaluations at schools not undergoing active renovation projects with PCB-containing materials include Jennings Elementary, Timothy Dwight Elementary, and Tomlinson Middle School; these three schools had a higher percentage of suspect materials that also exhibited higher chlorine concentrations in both interior and exterior samples relative to the average of all schools; activities could include more detailed inspection and survey of suspect materials with follow-up interim measures, as needed, to potentially include covering any deteriorating sealants or suspect sealants in high exposure potential areas; room or area cleaning; etc. Of note, the two elementary schools recently underwent exterior window replacement projects; therefore, these associated sealants should not be suspect for PCBs.
